RF pickup ↔ Remedies(?)

polar. mtg.
20.06.12

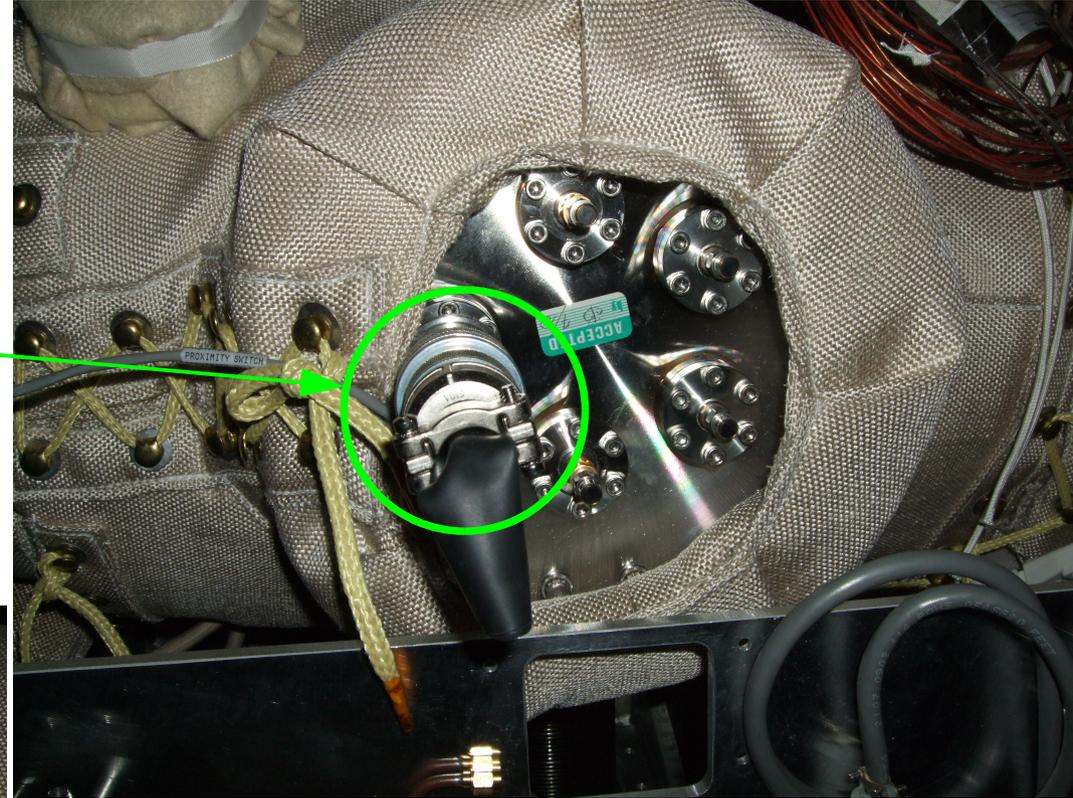
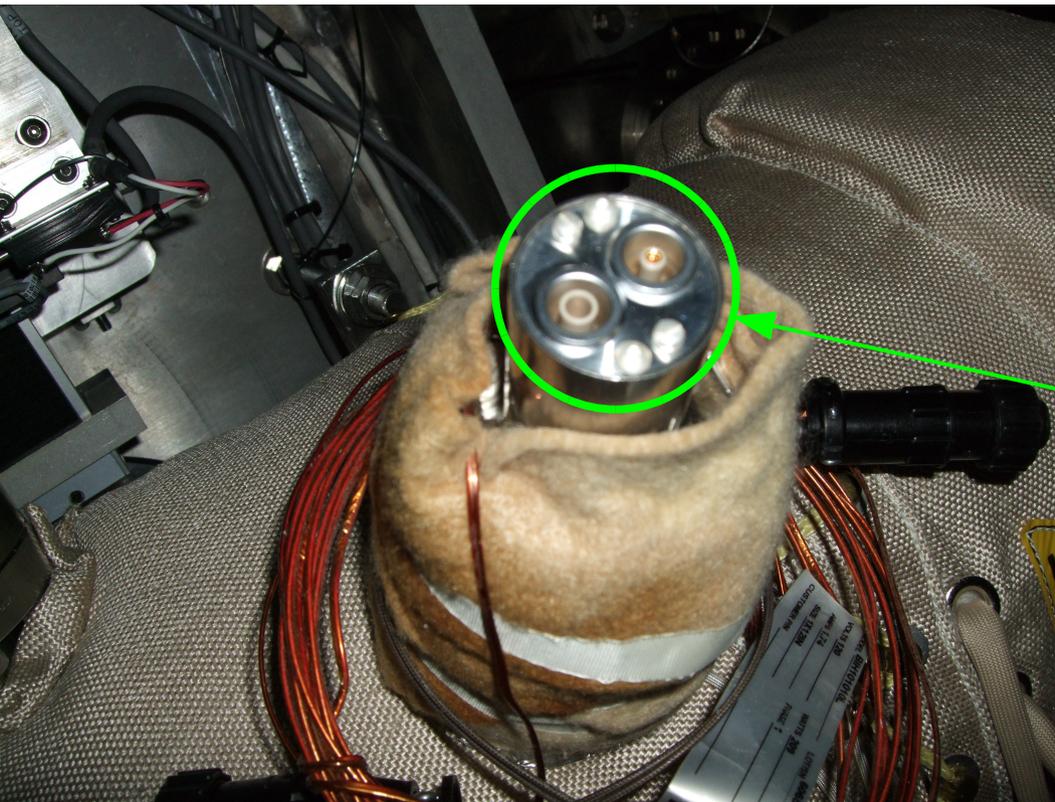
- Stochastic cooling pickup signal cable (twisted pair) removed and feedthrough terminated (M. Brennan)

- Stochastic cooling vacuum gauge feedthrough was floating, now grounded (M. Brennan)

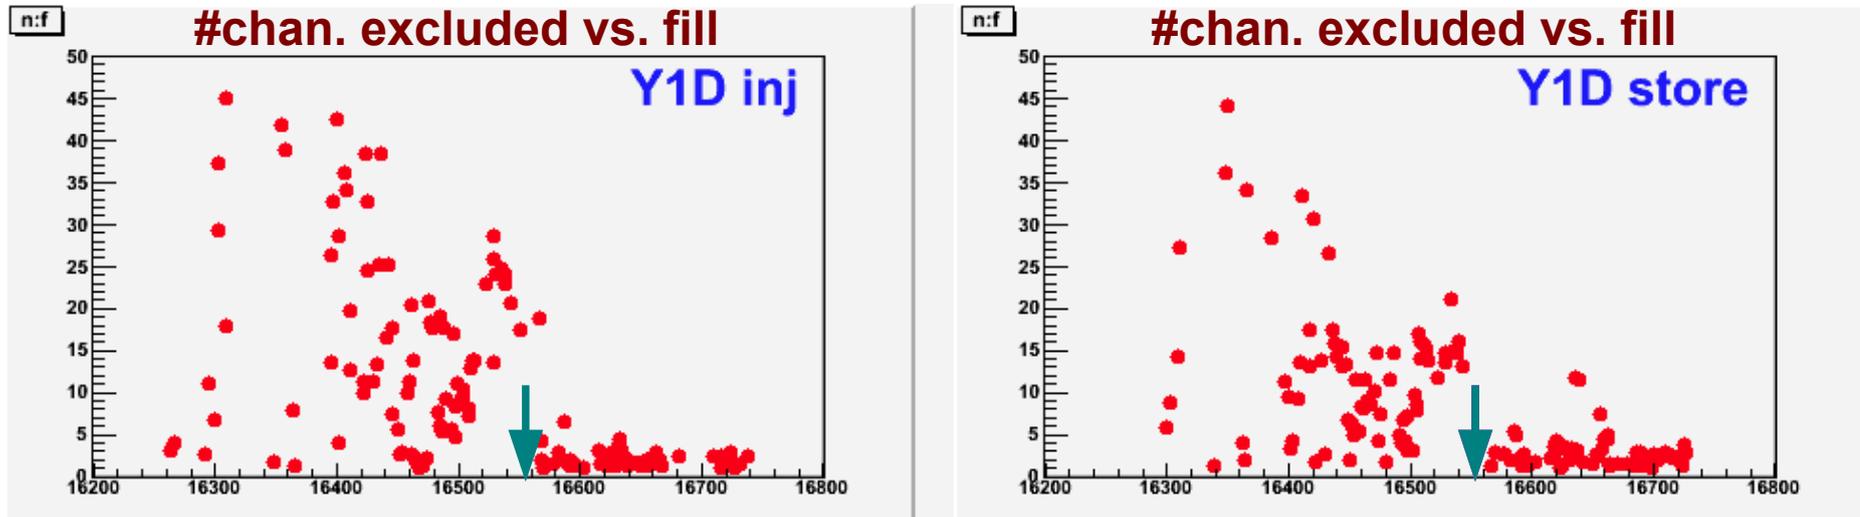
- Sharp drop in #chan. excluded offline (Y1D next to pickup):

SEEMS THIS WAS THE MAJOR SOURCE OF OUR PROBLEMS

- Close coordination with RF group on possible RF sources, remedies
- Antenna to monitor external RF?
- On our side external shielding & grounding

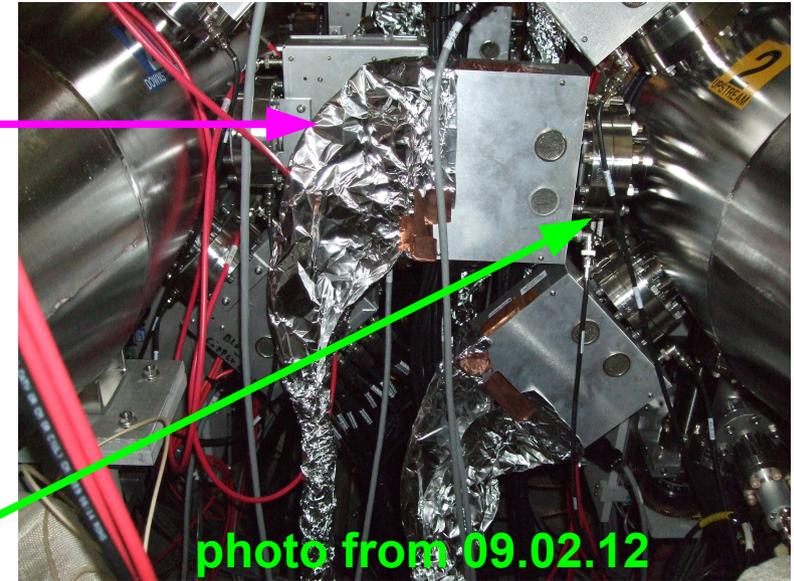
- On 04.04.12 front side of boxes (near chamber) wrapped with Al foil

- With applied RF clear reduction of RF seen on scope especially near connector hole, flange
- Confirmed in Bldg. 930 bench setup?

- Complete redesign of box (not electronics) (CAD electronics group?)
- Attention to shielding & grounding, connector holes, ...
- Ventilation?

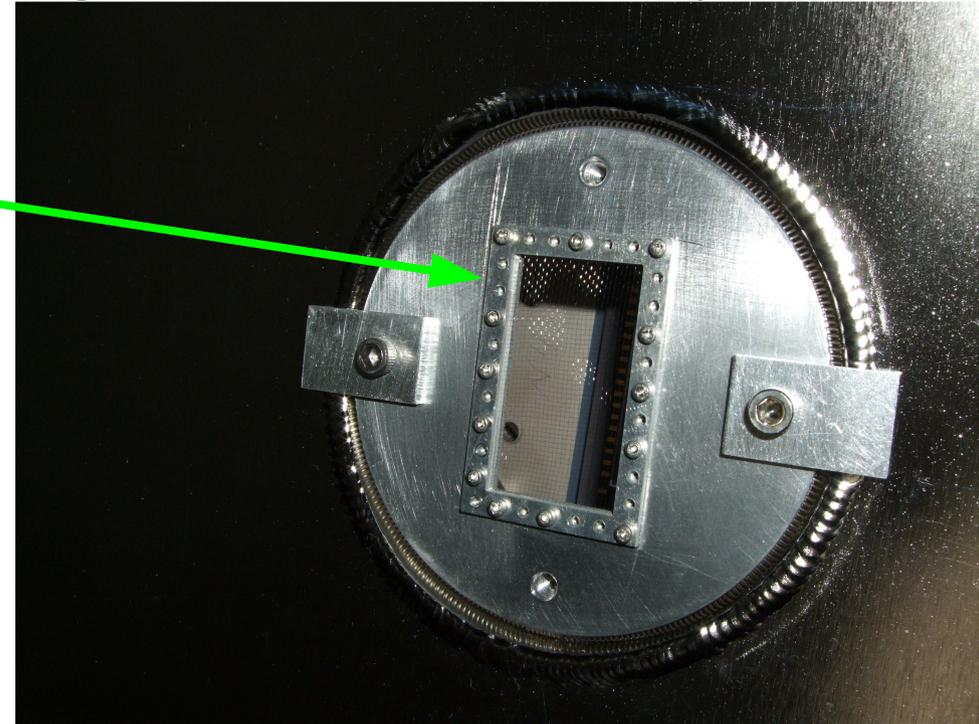
- On 14.03.12 Y2U detectors 1,6,3,4 moved farther from port aperture (det. 1,6 spacer flanges; det. 3,4 long→short pin detectors)
- Results? (#chan. excluded inconclusive)
- On 11.04.12 new tungsten RF screens B1-4, B2-3, B2-4, Y2-4
- RF shields on B2-1 & B2-6 were misaligned, repositioned
- Results? (#chan. excluded inconclusive)
- Studies with applied RF in Bldg. 930 bench setup give good comparisons of relative merits different screens
- Results?

- Apply best knowledge from bench tests; new screens
- Carbon acceptance thru screens?
- Spacer flanges? (BNL 1mm short pins already?)

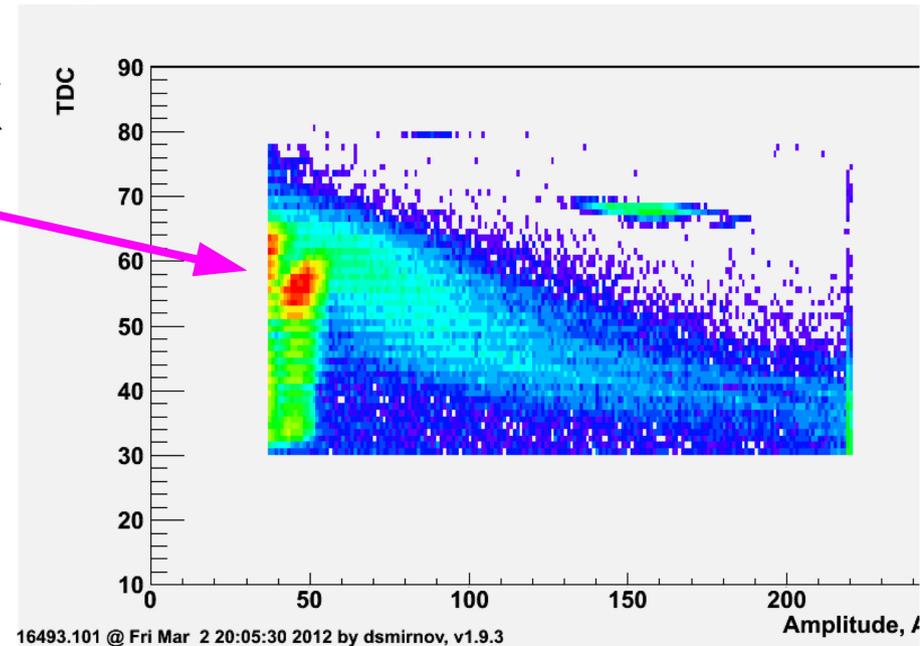
- MUX circuit diagram show “off” chan. are open circuit
- On 29.02.12 Y1D ch. 25 bypassed MUX
- Result: RF noise still in data
- Chan. replaced in MUX on 14.03.12
- MUX housing found not grounded;
grounded to polarim. frame 14.03.12

- MUX may or may not be source of RF pickup
- Also, MUX electricians broke down twice, requiring tunnel access
- Move MUX tunnel→near counting room solves both problems
- Requires ~150 signal cables from tunnel→near counting room
- \$\$\$, manpower?
- Or: change circuit so “off” chan. are *not* open circuit

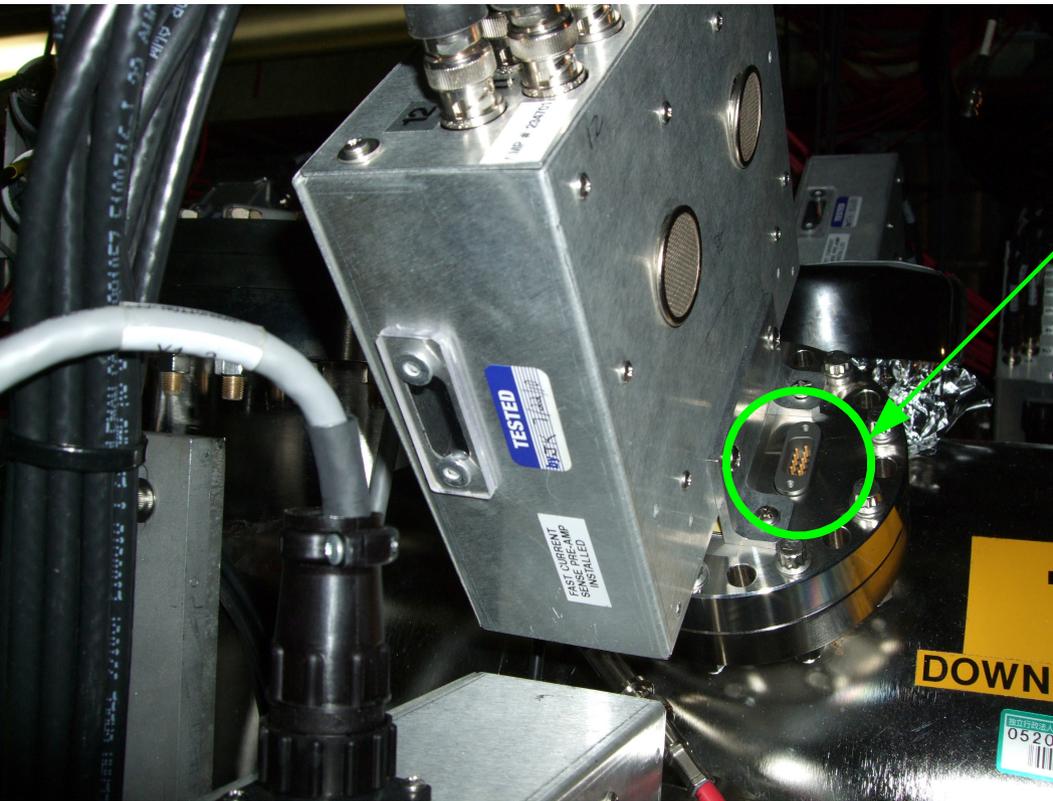
- 24 unused feedthroughs on detector flanges grounded
- 8 viewing port windows shielded with Al foil
