RHIC Polarimeter Target Frame Test

August 6, 2014
Polarimeter Group Meeting

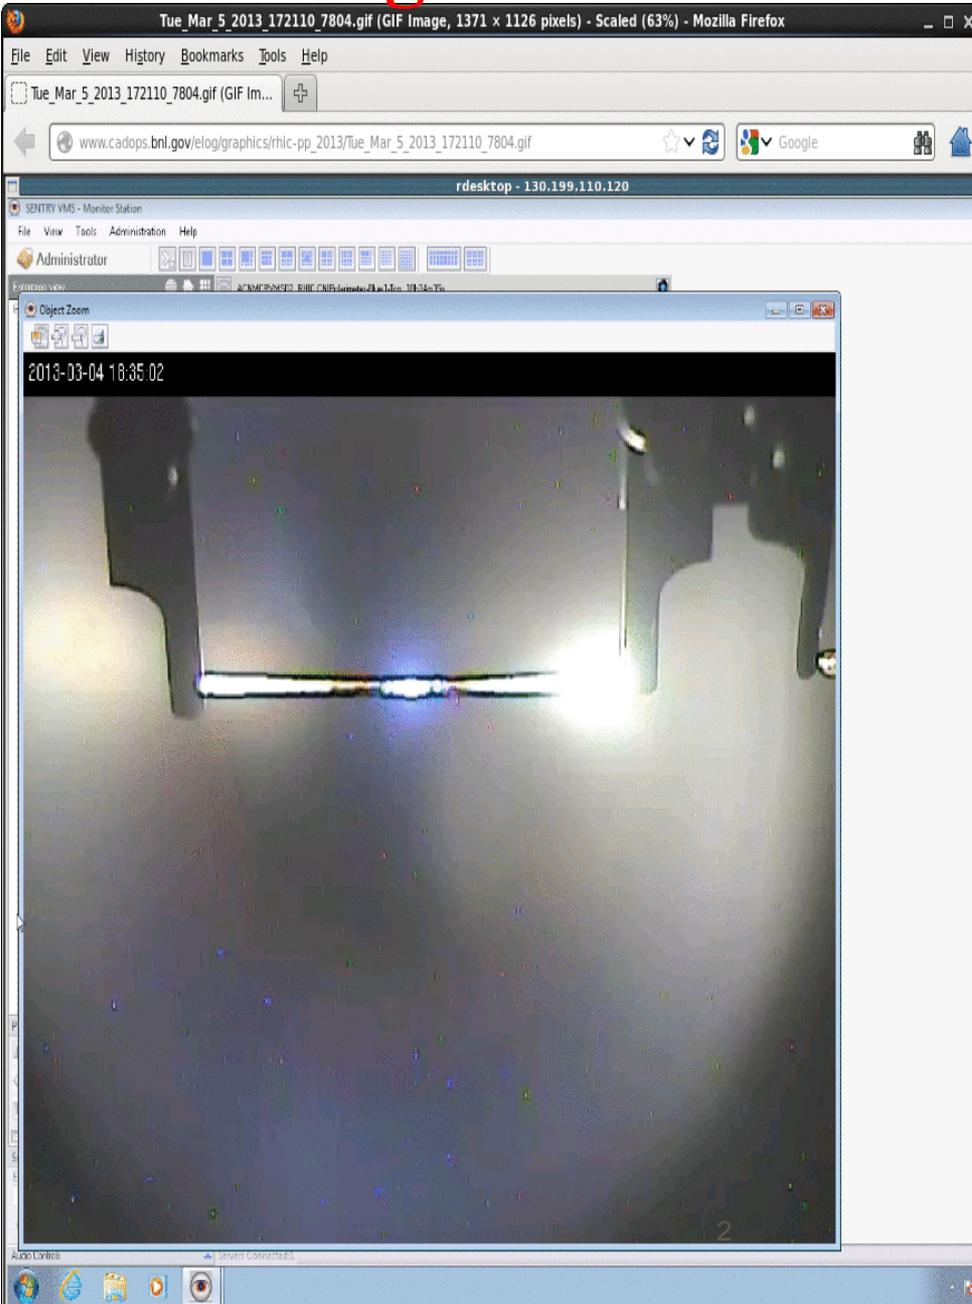
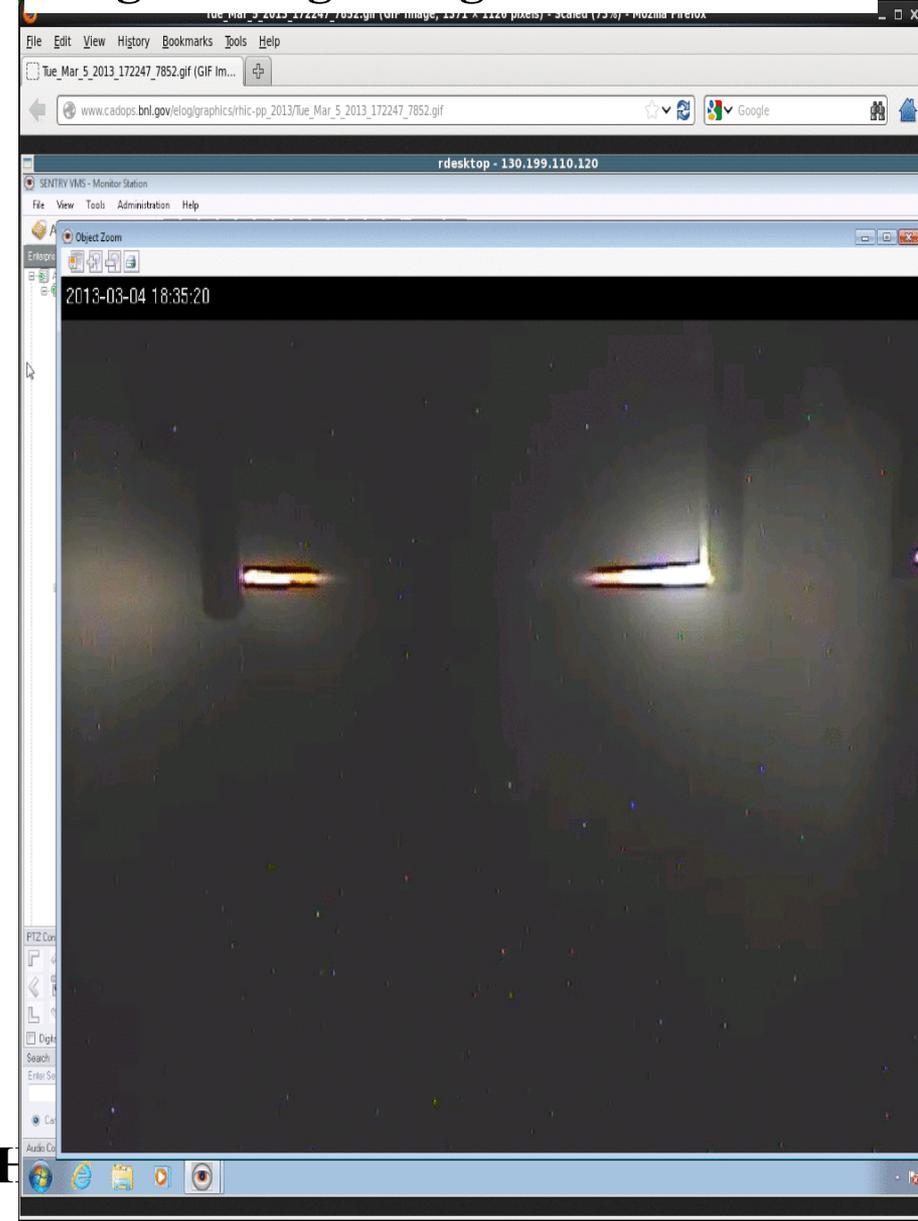
B1H1 Target in Proton Beam Last Run

Target tails glowing when off beam

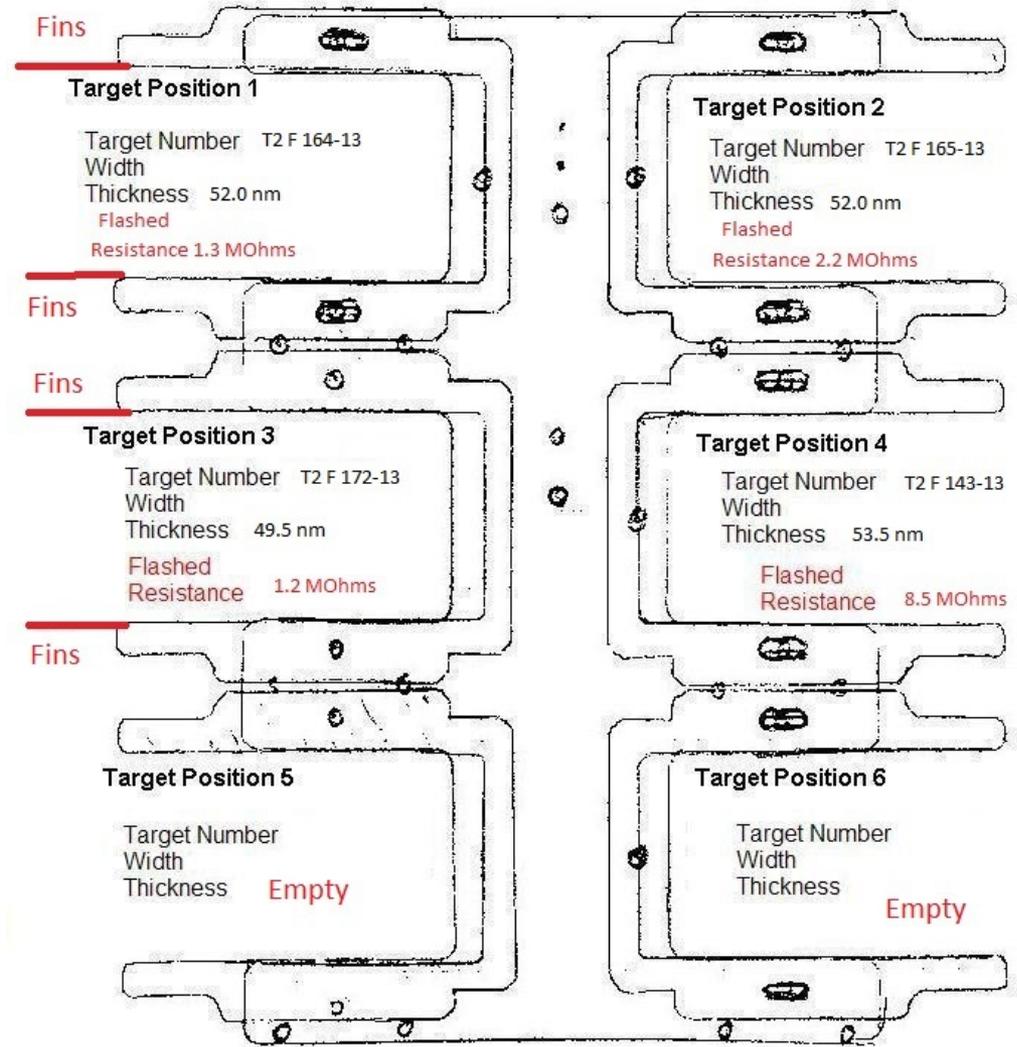
Blue 1 Horizontal
Upstream

- Targets 1-4 were used for Au beam.
- Only target1 had chance to be used for He3 beam.
- Targets 2 and 4 were lost during target switch.
- Note that Target4 resistance is much higher than others: 8.5MOhms vs. 1-2 MOhms.

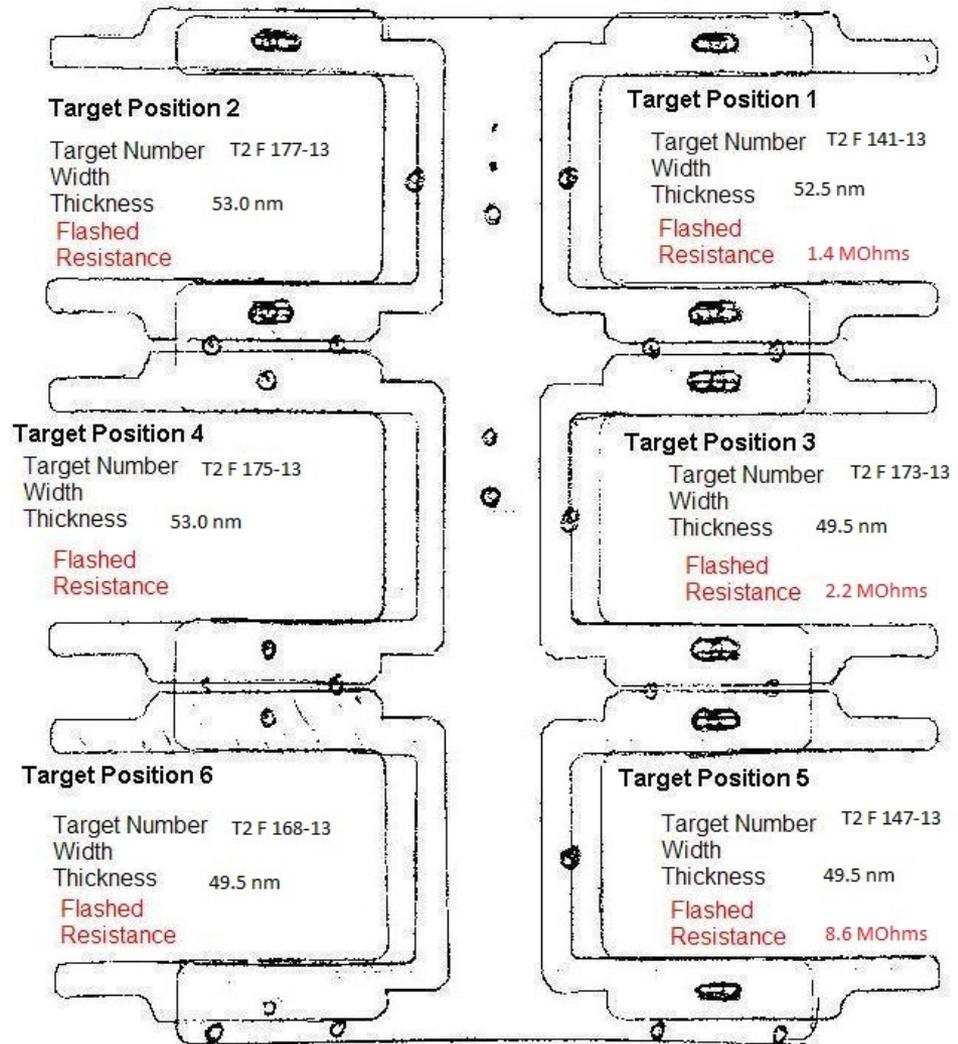
**Blue 2 Vertical
Downstream**

Targets used for He3 beam.
No resistance info for
targets 2 and 4.

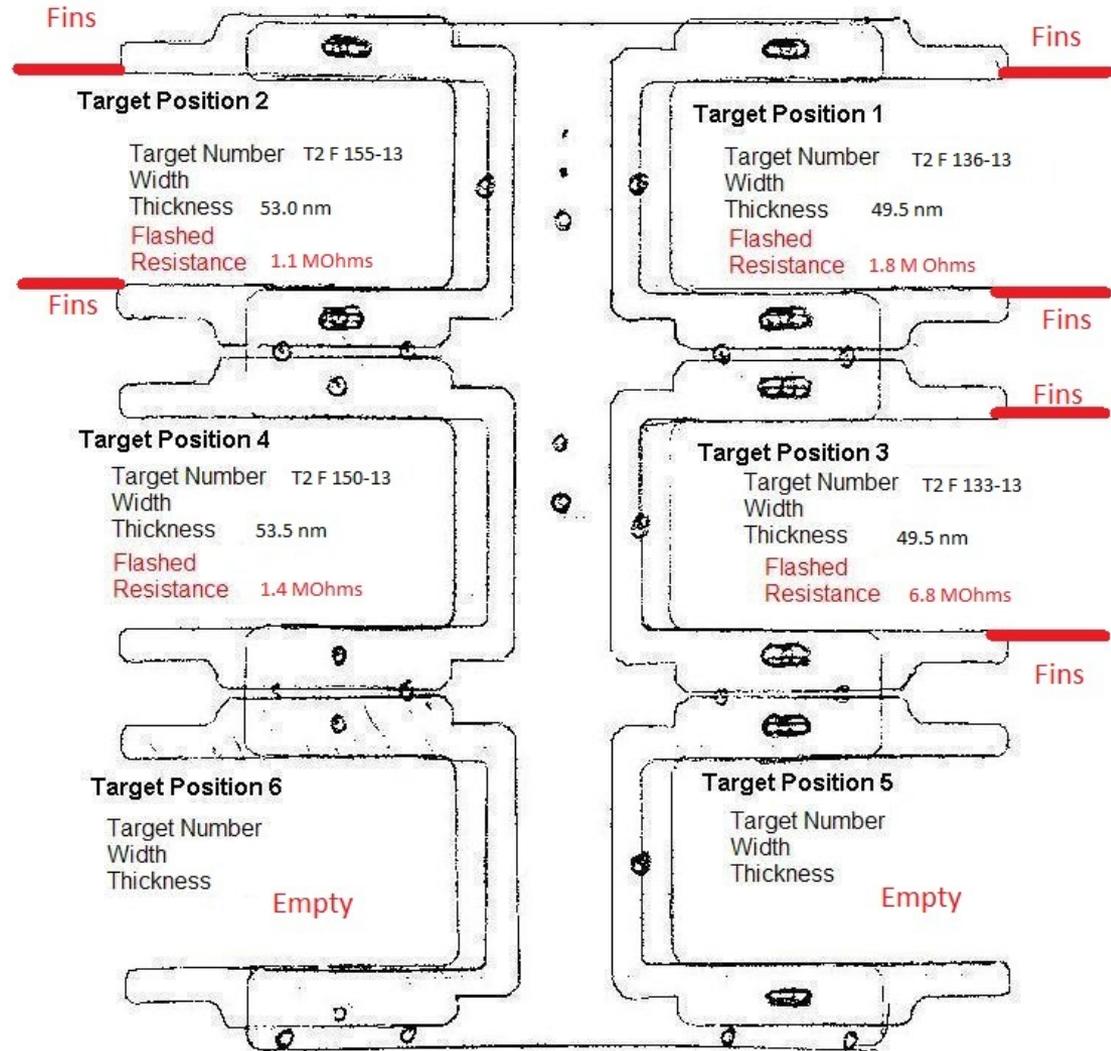
Blue 1 Vertical
Upstream

Targets used for He3 beam but no video recorded. Target 3 was gone (no beam loss generated); much higher resistance for this target: 6.8M Ohms vs. 1-2M Ohms.

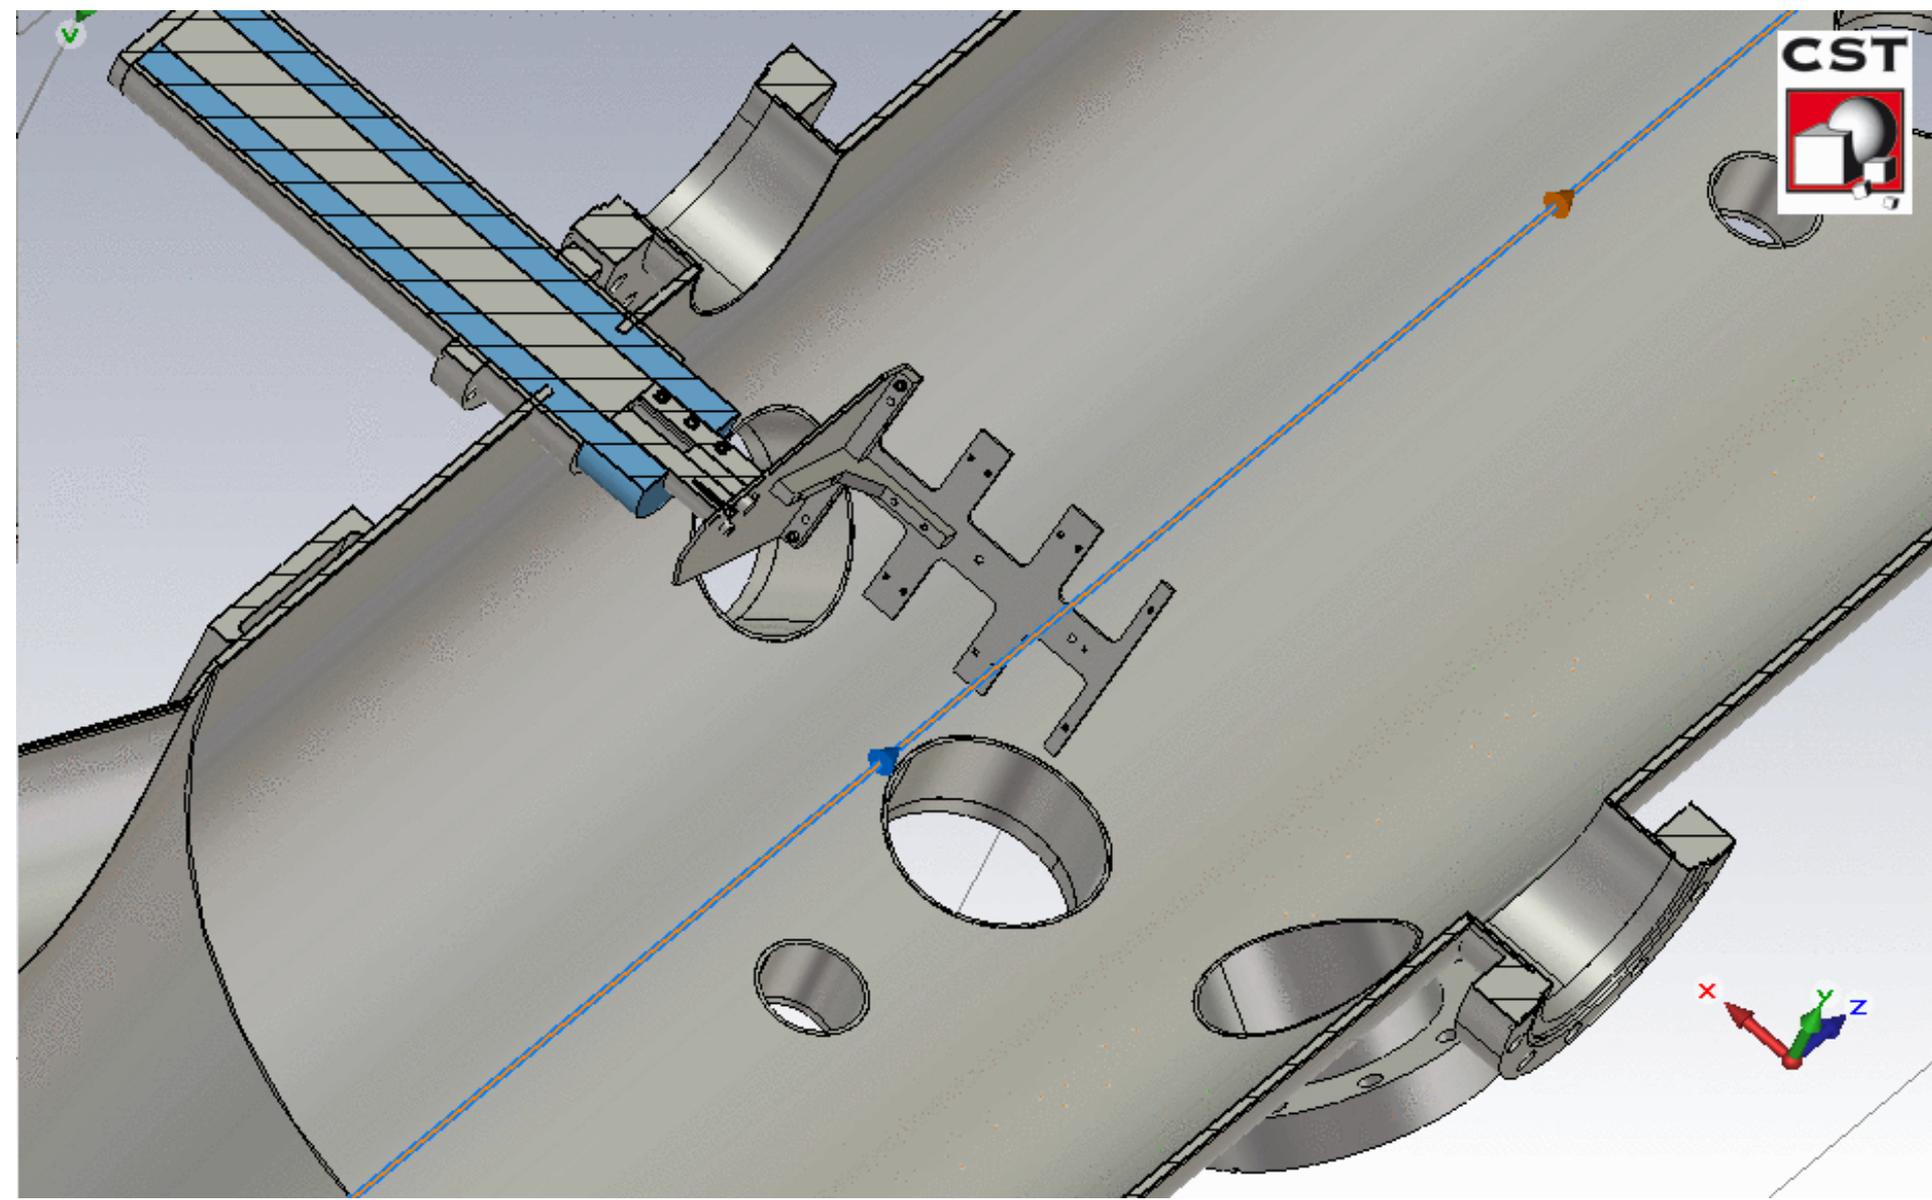
Provide surface for the field lines to “spread out”

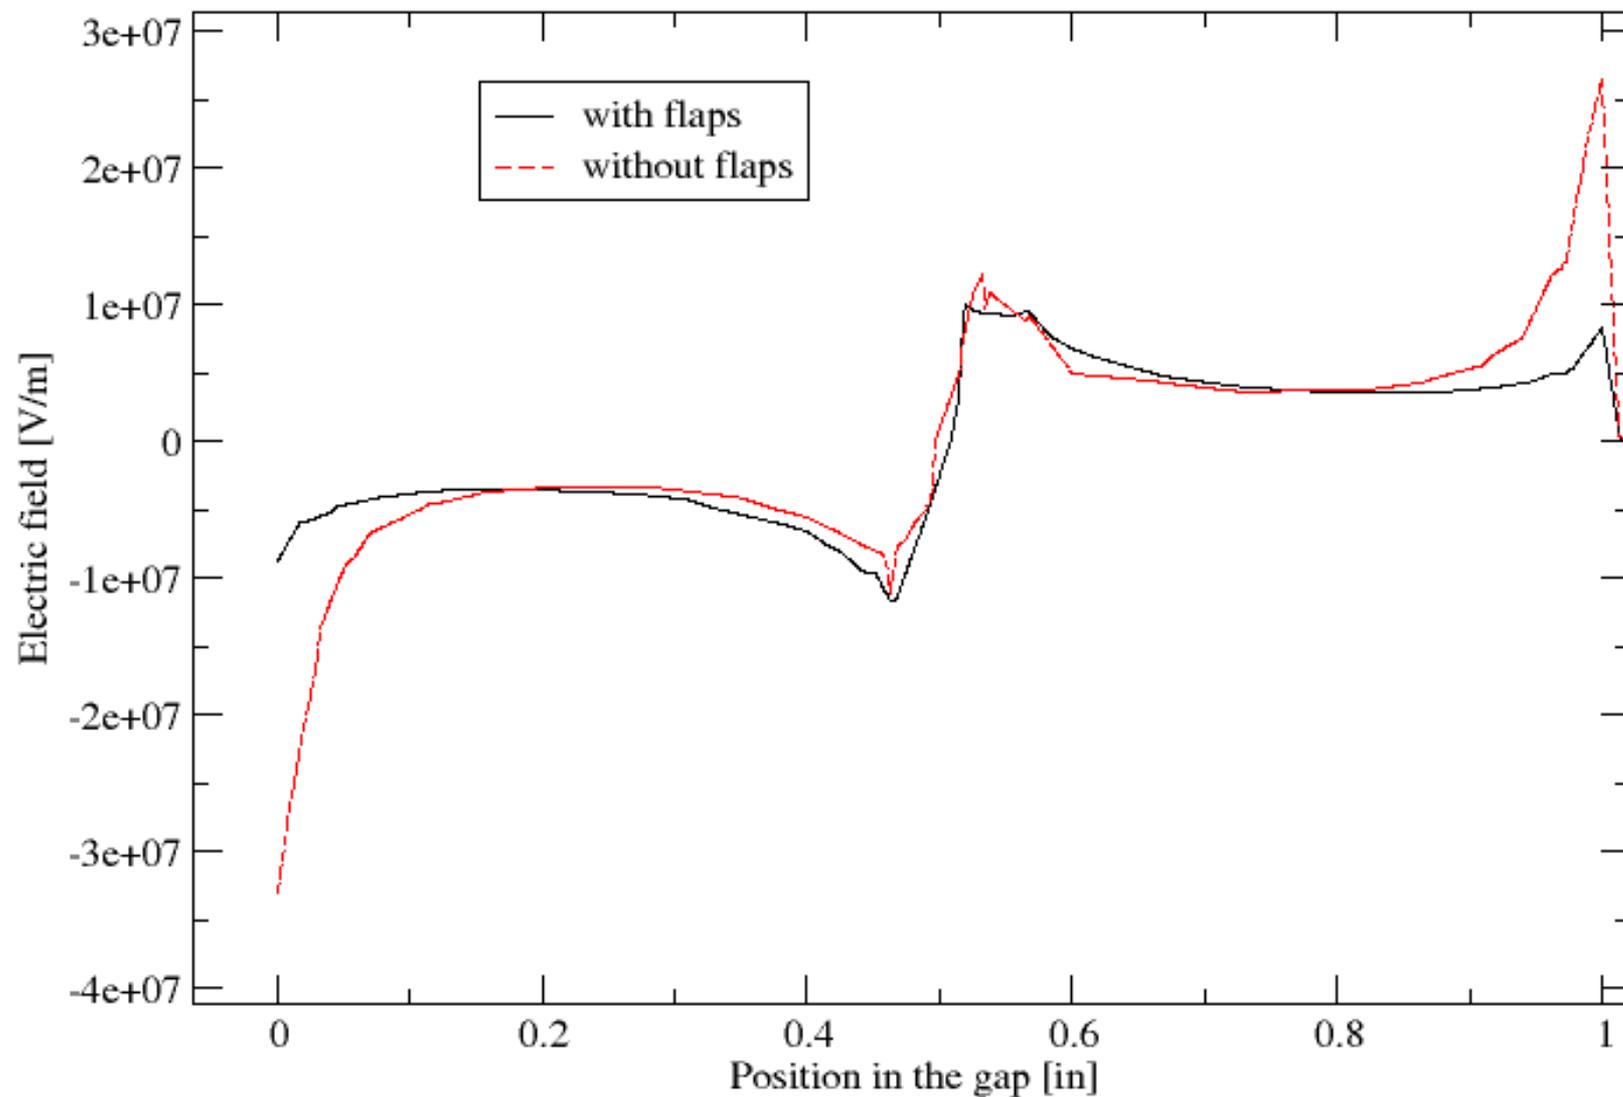
Beam next to the wire

x direction

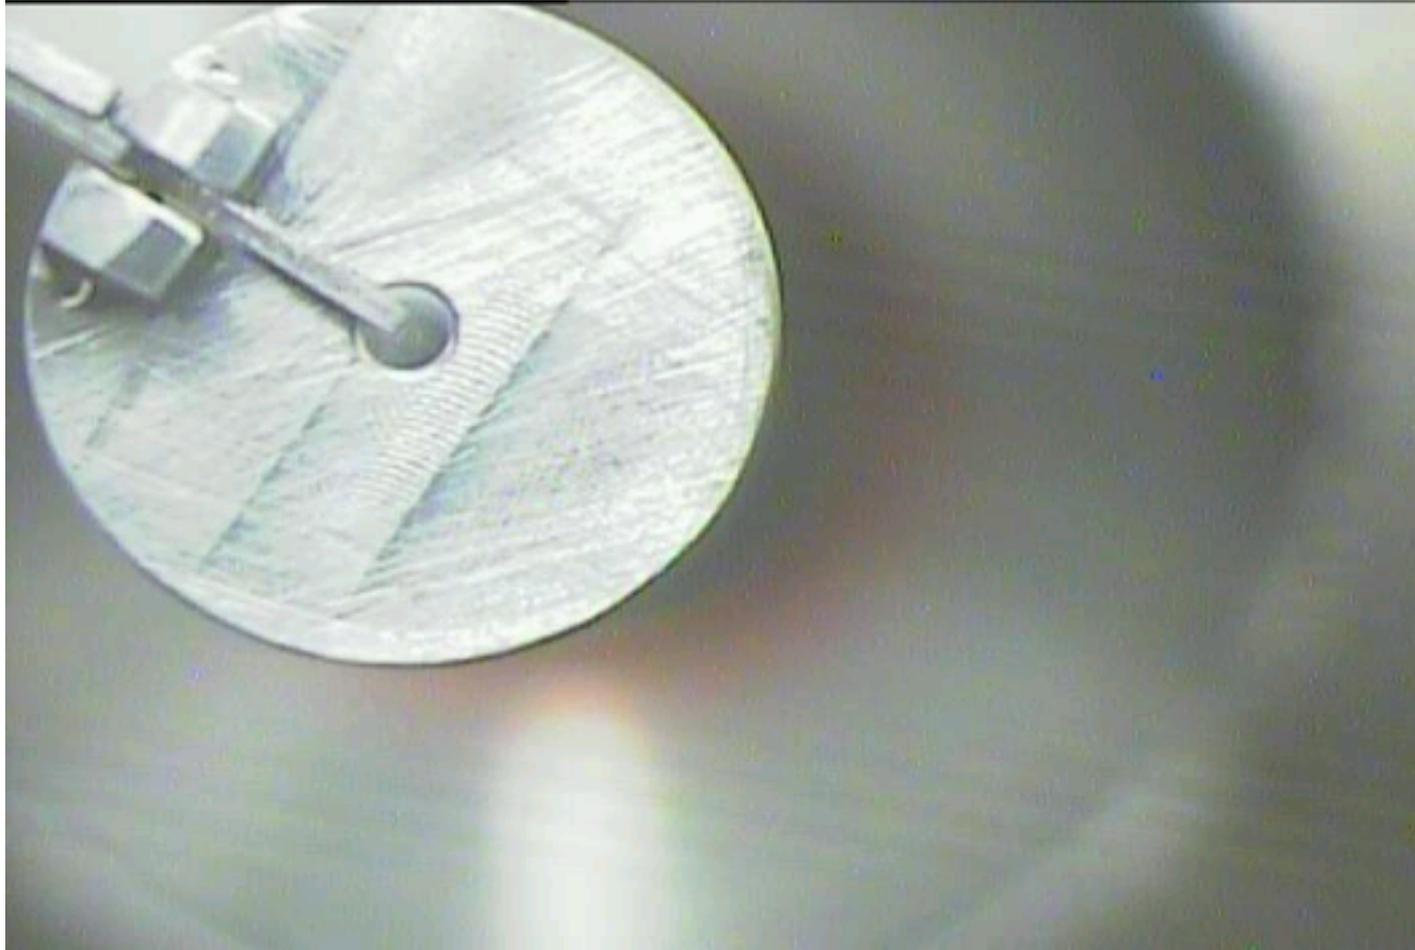
B1V1 Target (with Fins) from Top Camera

With modified design, so the reduction should be 10 times, instead of 4-5 times.

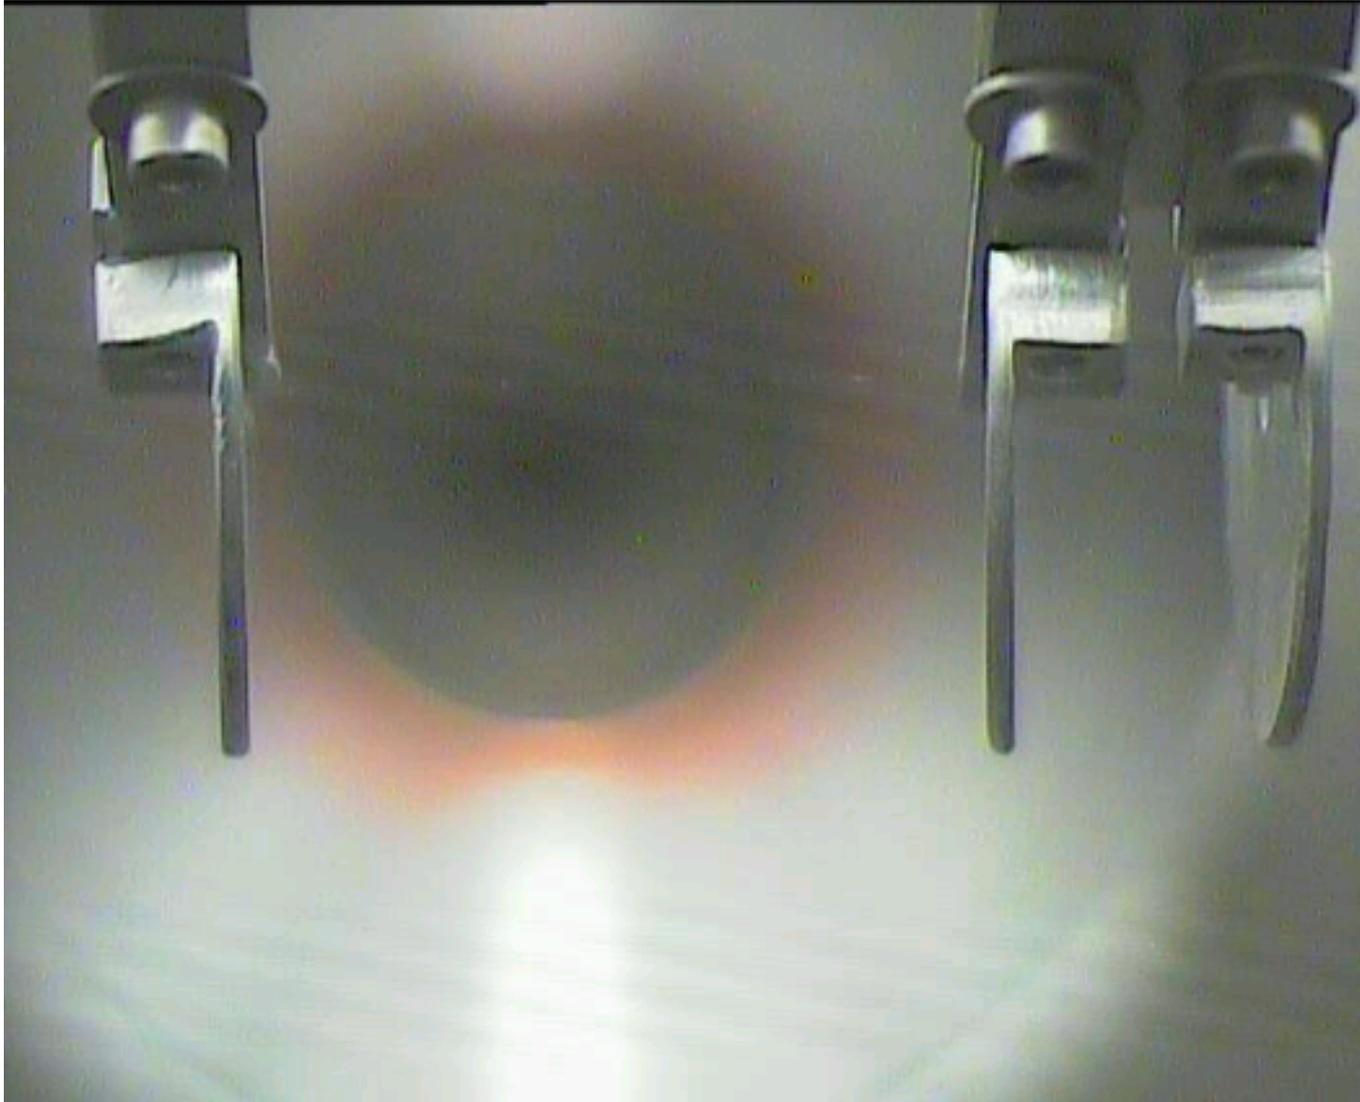
B1H1 Target (with Fins) from Top Camera

Target is visible

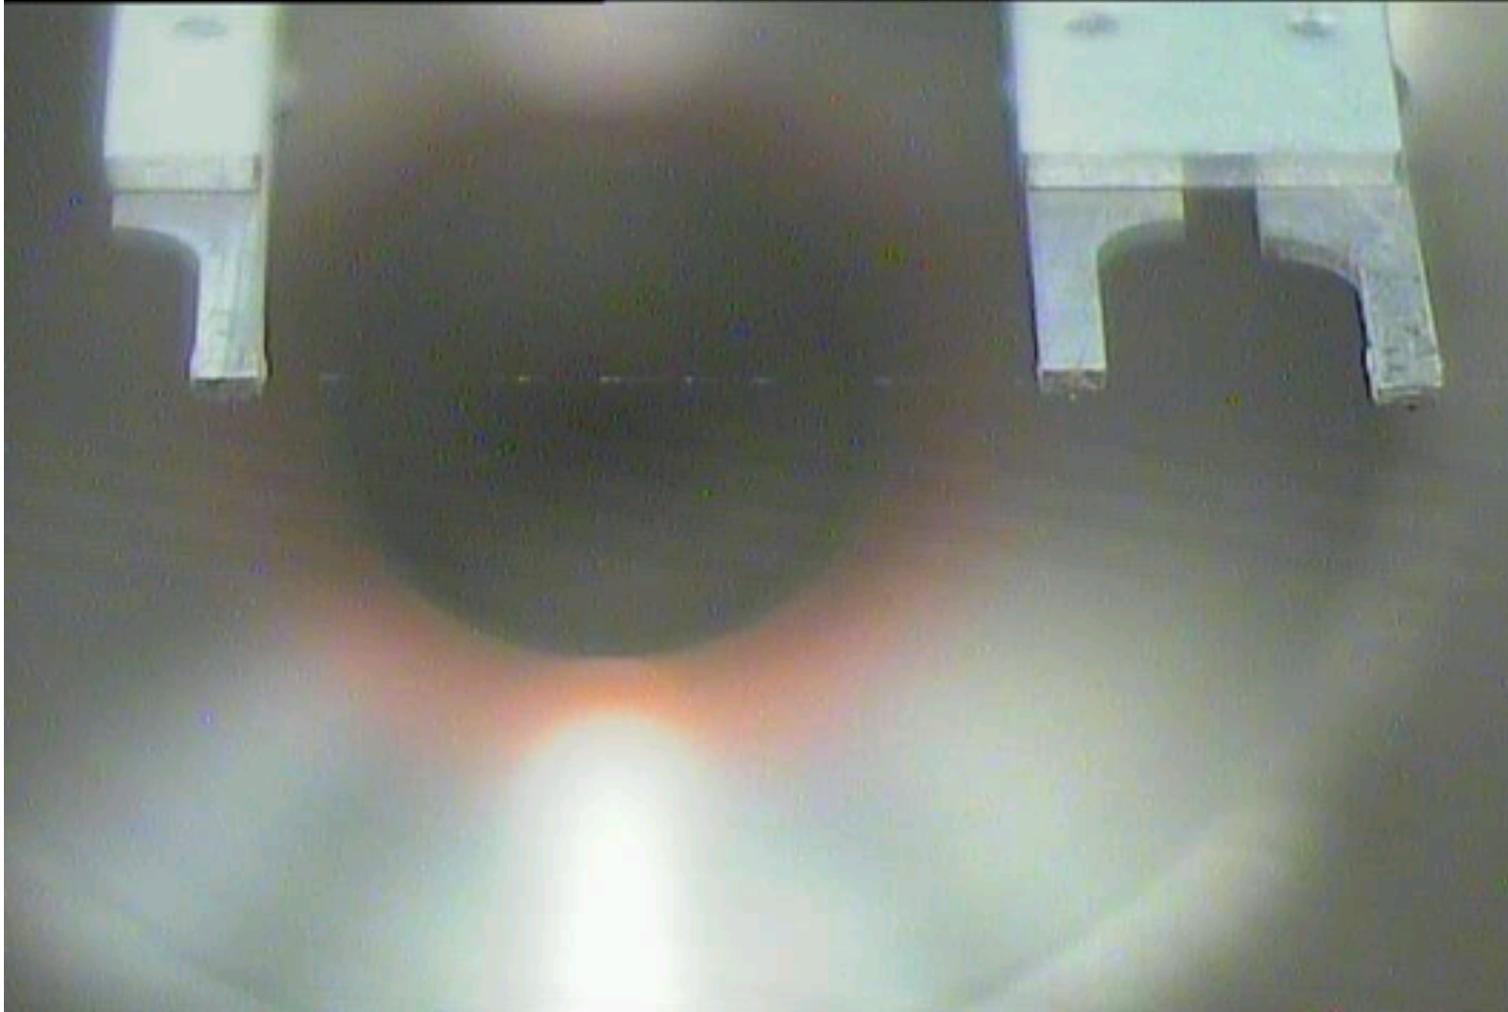
B1H2 Target (without Fins) from Top Camera

Target is visible

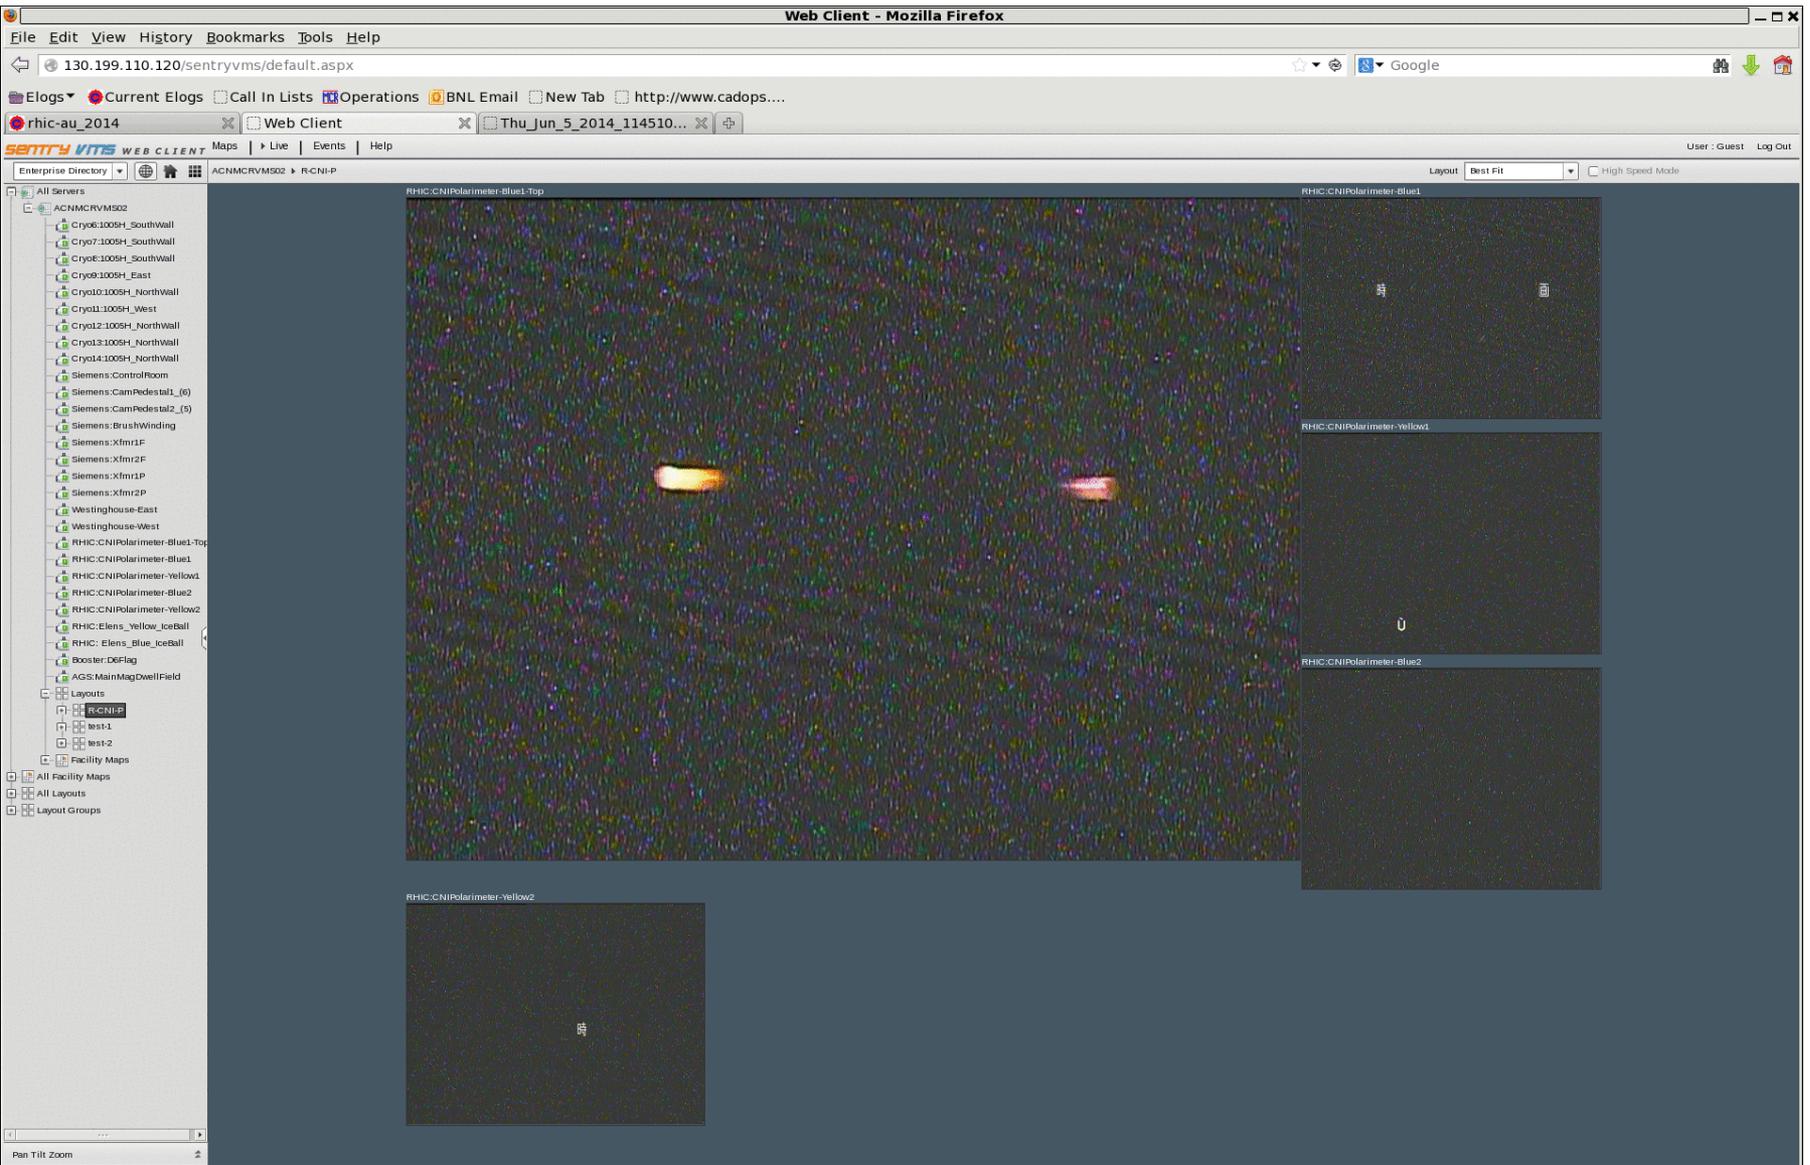
B1H2 without Fins Near Au Beam (1.5cm away)

Brighter light than with fins.

- June 10, 11:38-11:45. Tested B1H1 (with fins) and B1H2 (without fins). The glowing light is definitely stronger for target frame without fins. we tried a few times and it is reproducible. Au intensity 66×10^9 (peak current 1.4A).

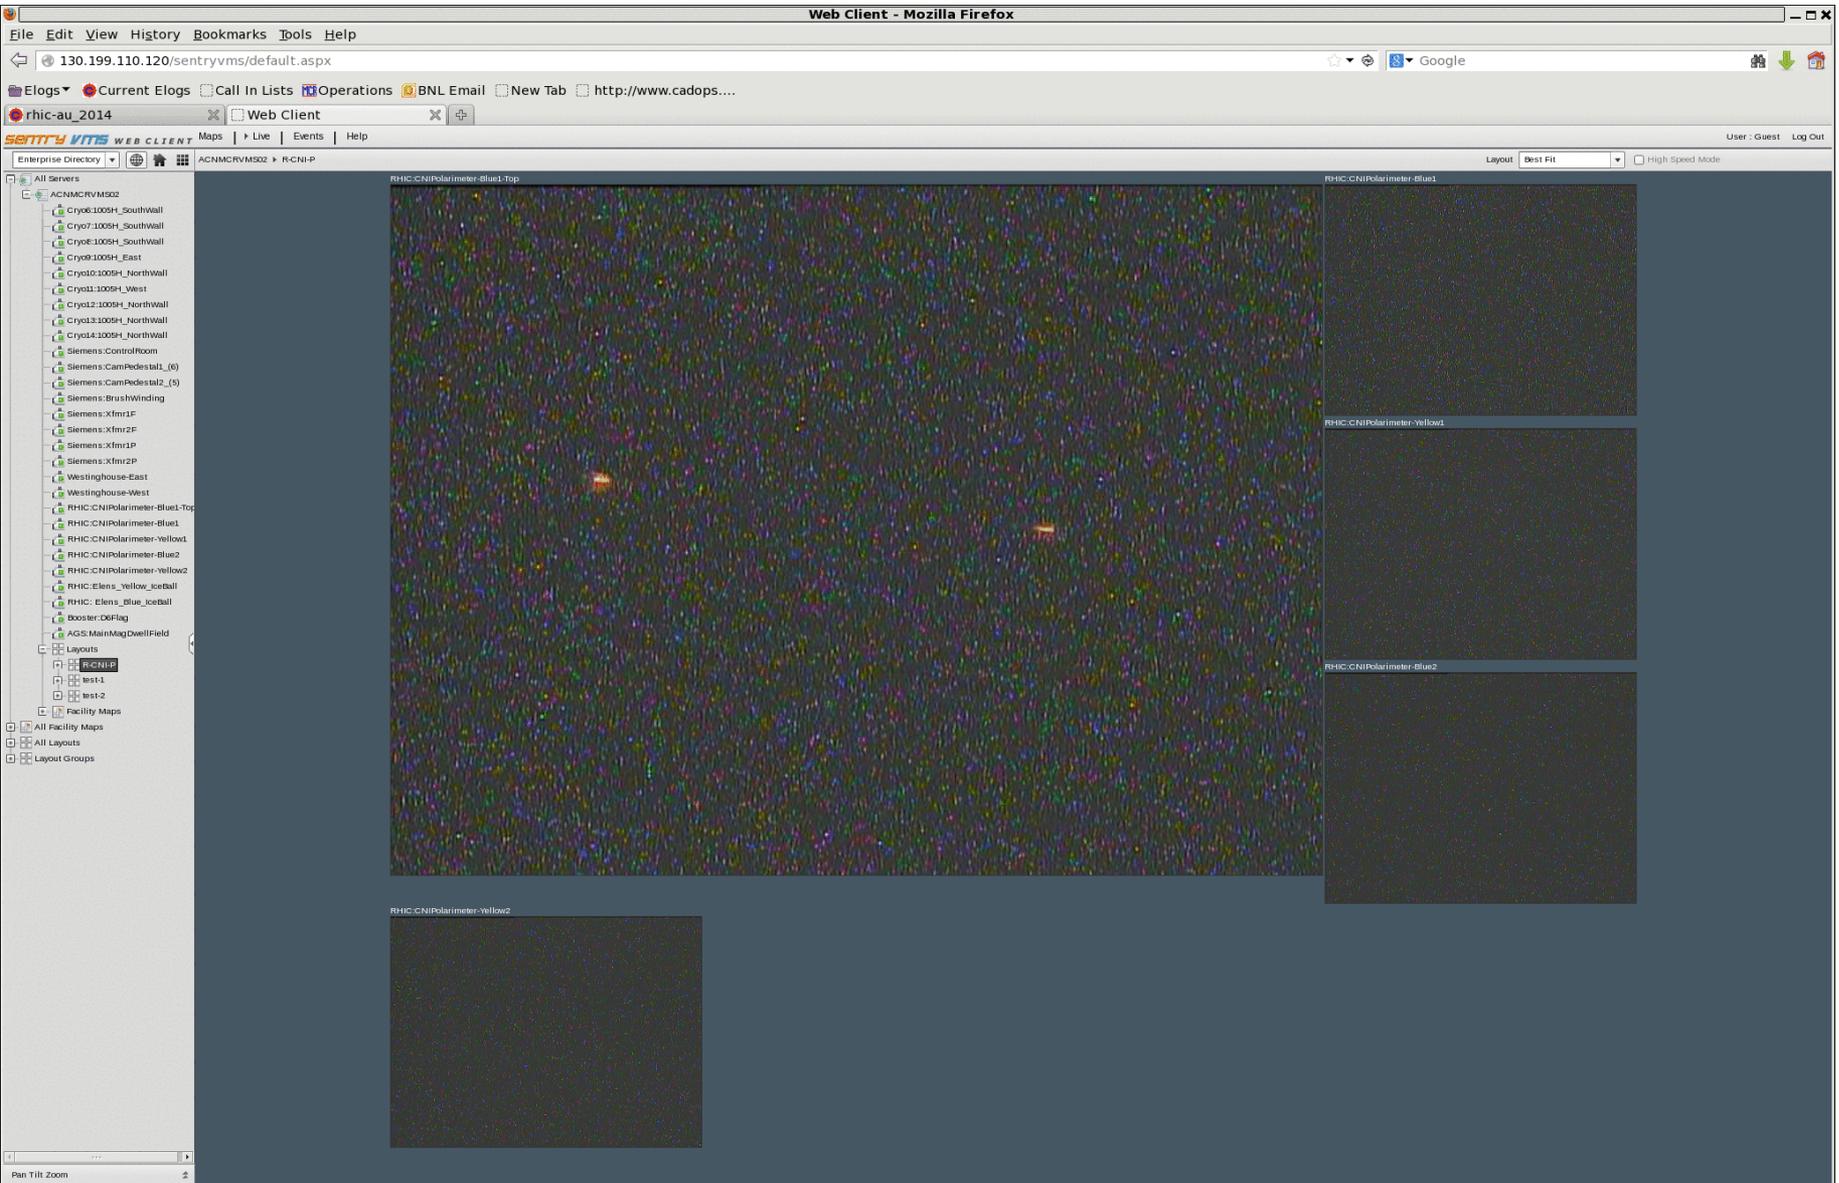
B1H4 without Fins Near Au Beam (1.5cm away)

Brighter light than with fins.²¹

- June 12, 17:52-17:58. The Au total intensity was 67×10^9 (peak current 0.75A). Tested B1H3 (with fins) and B1H4 (without fins). Overall, the light from this pair is dimmer than B1H1 and B1H2. But the light from frame without fins is still brighter. We also ramped down the RF voltage from 650kV to 100kV in 20 sec. The light disappeared for the no-fins target frame. Then when we switch back to B1H3 (with fins), there is no visible light either. The correlation of light with RF voltage is also established.

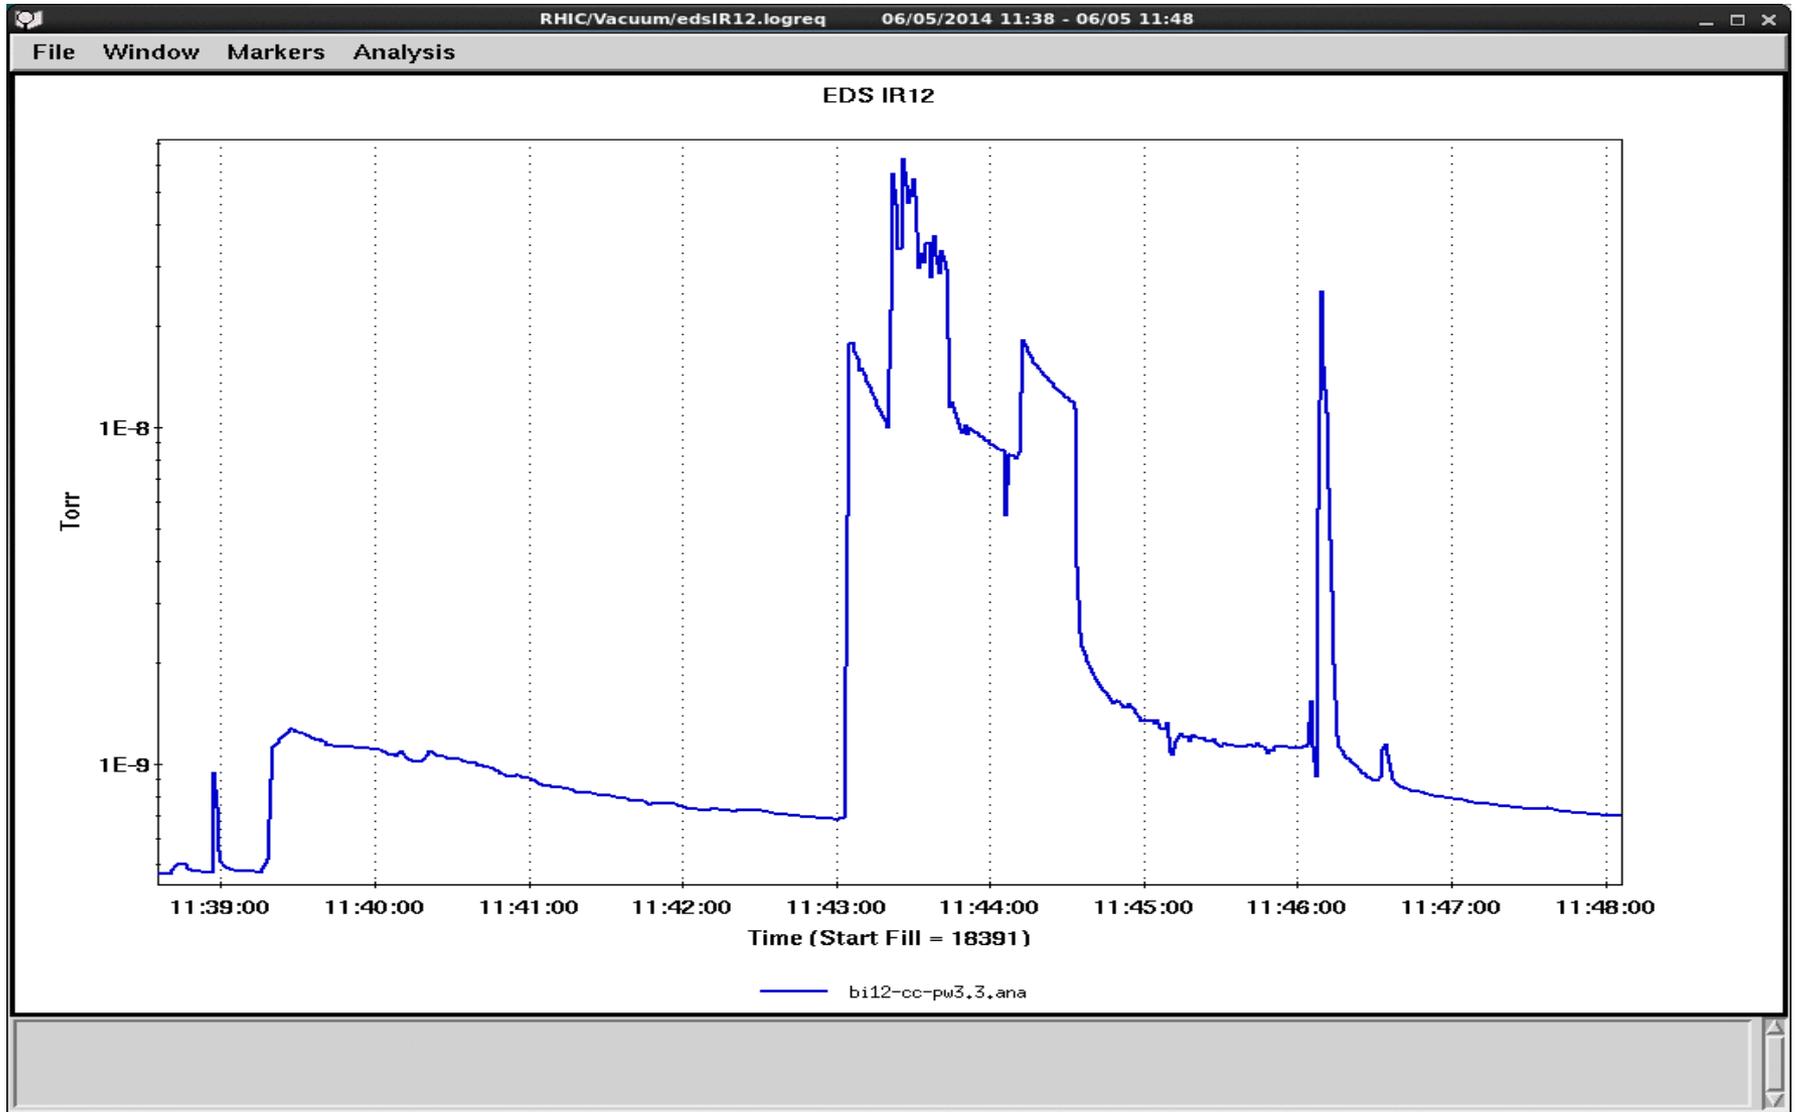
Vacuum Pressures(6/5), No Target Position Logged

No target positions were logged for the first day. But the vacuum spikes were associated with every target motion. They are quite large spikes compared to later time. They were caused by gas in the bellows. Since they have not been moved for awhile, the vacuum spikes are quite large compared to the spikes at later time. It also takes longer time to recover.

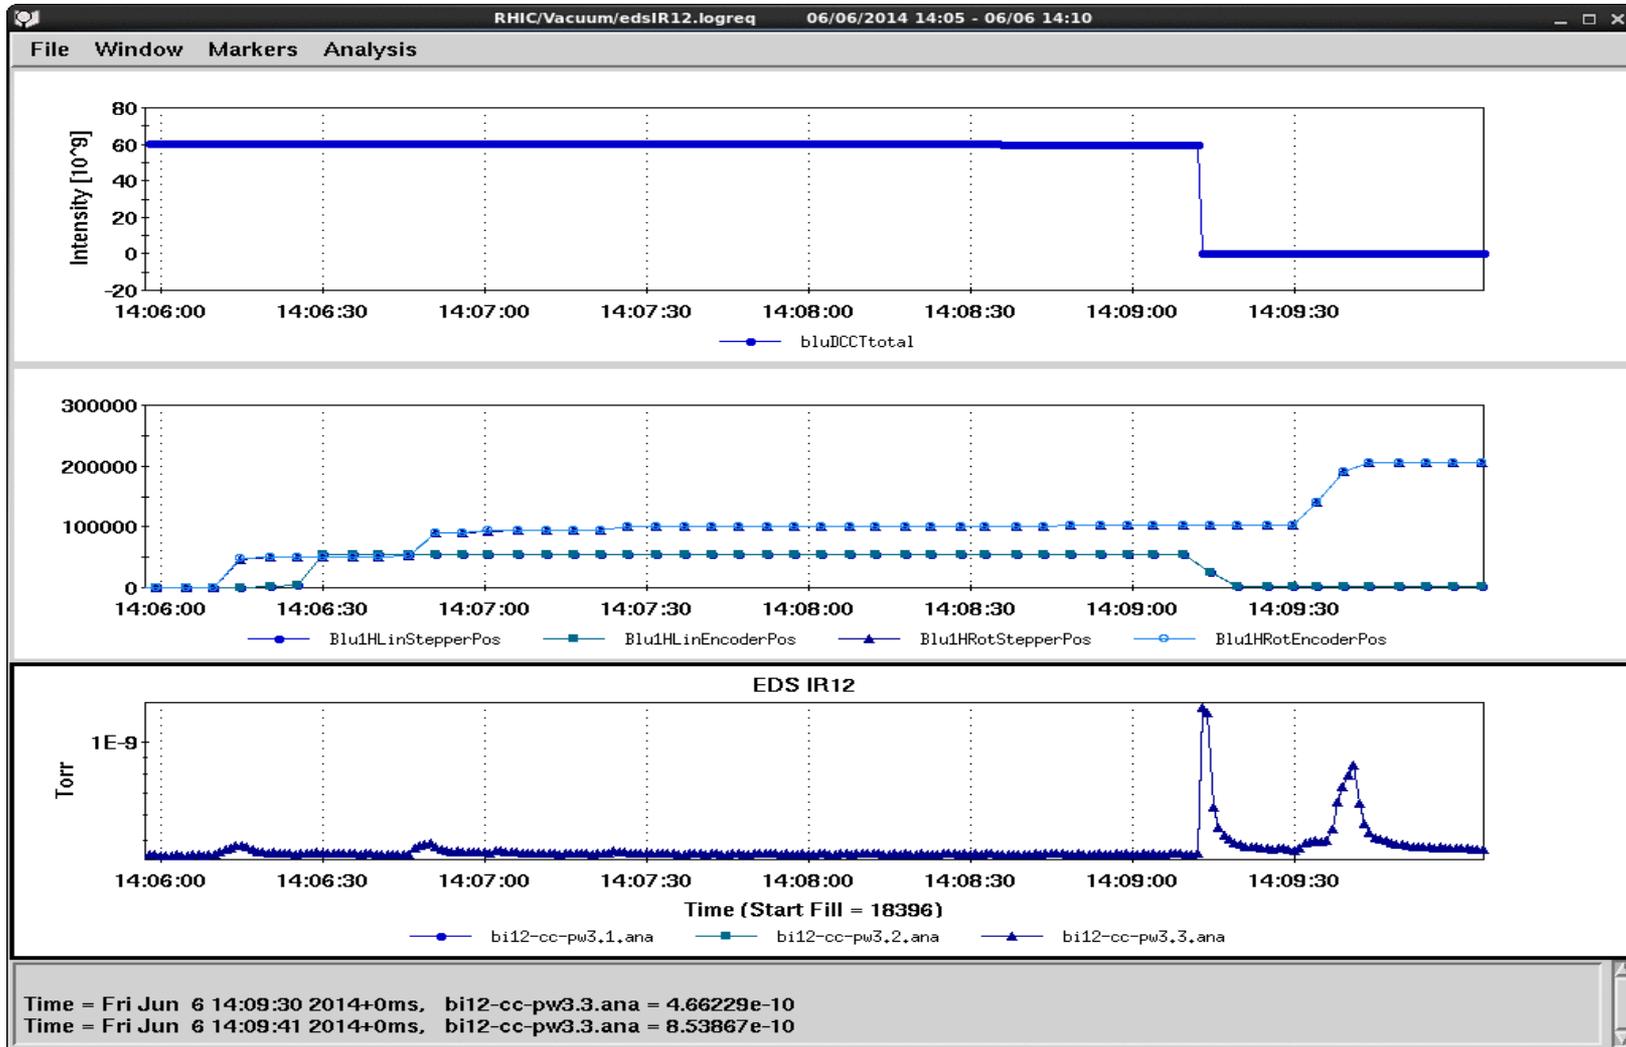
Target Position and Vacuum Pressures(6/6)

The vacuum spikes were smaller this time. The biggest one was due to beam abort event.
