RHIC Polarimeter Target Frame Test

August 6, 2014
Polarimeter Group Meeting

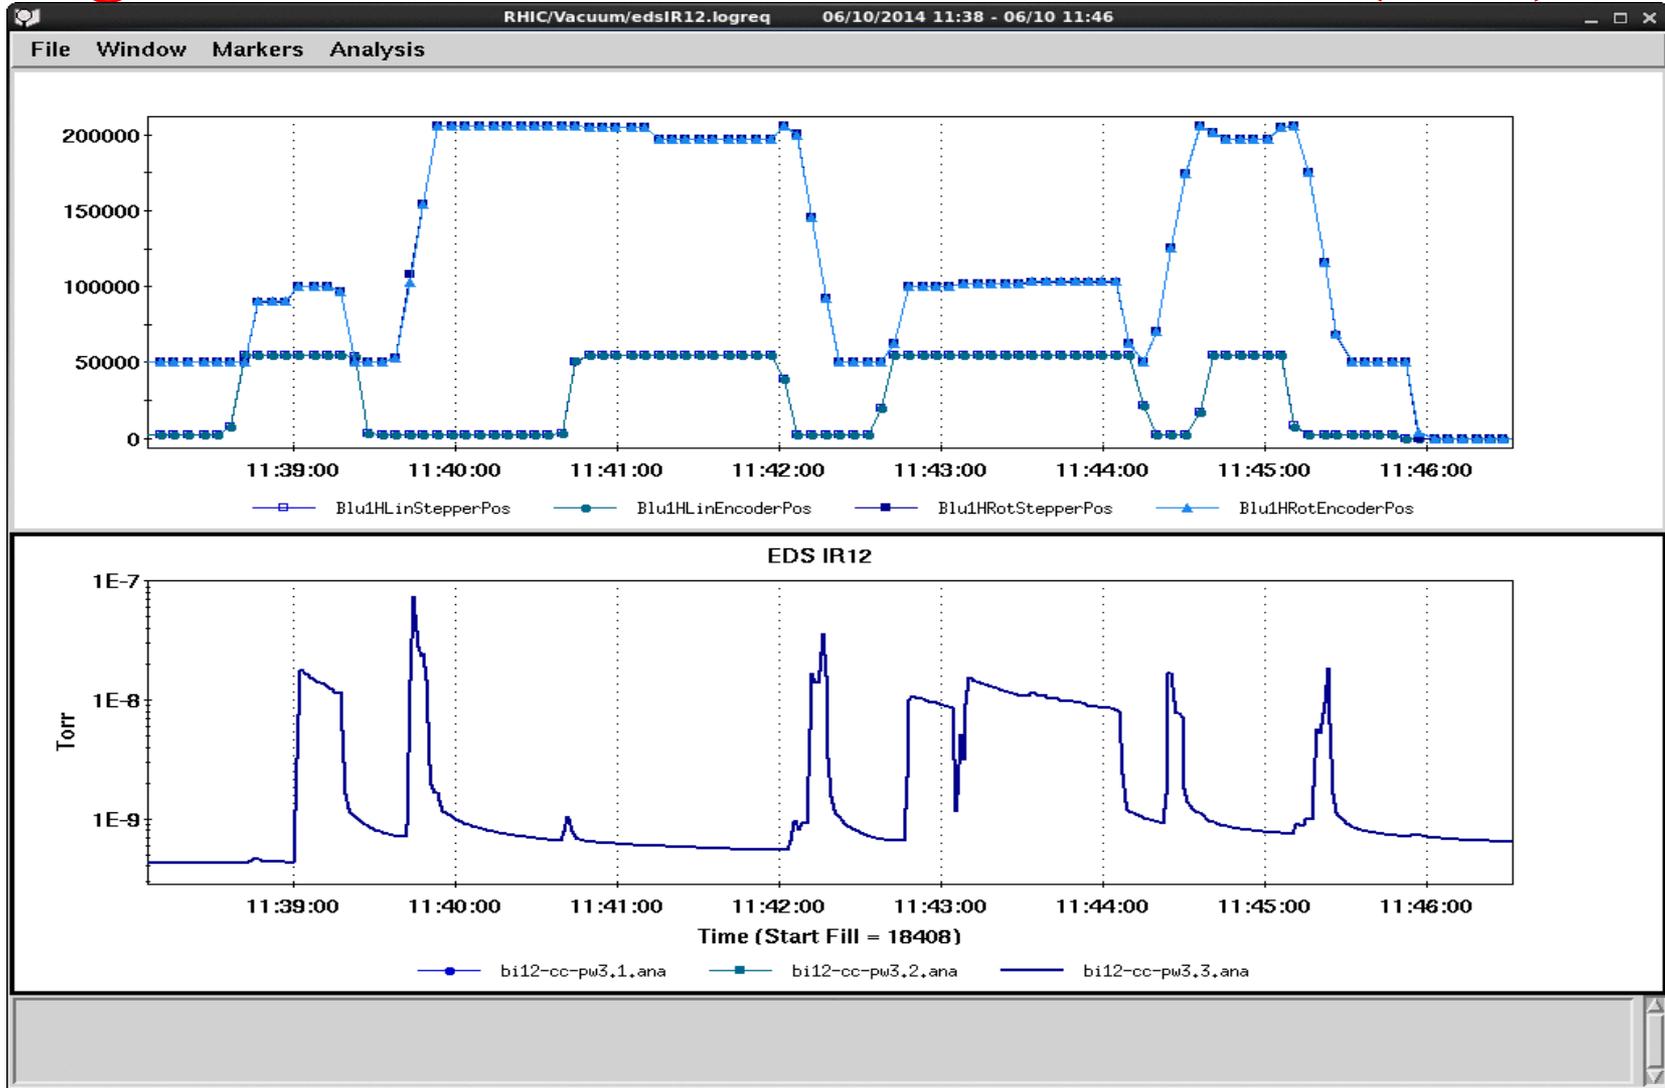
Target Position and Vacuum Pressures(6/10)

Some vacuum spikes took longer time to go away.

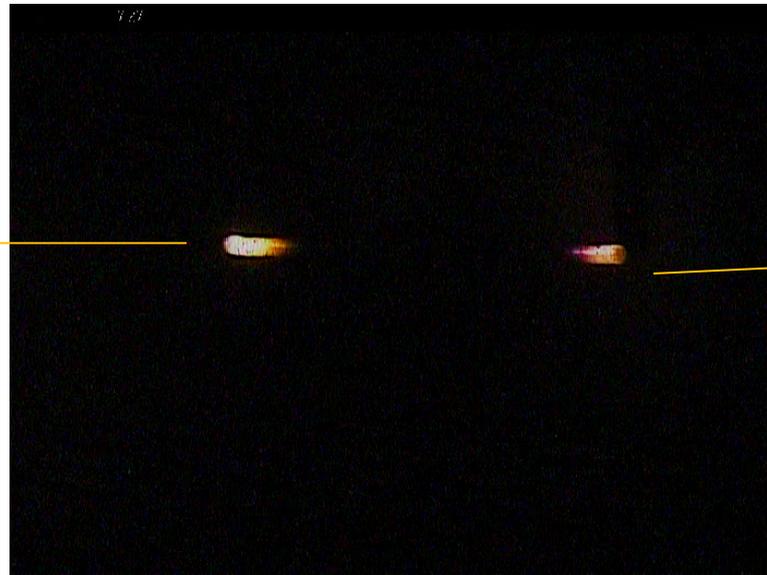
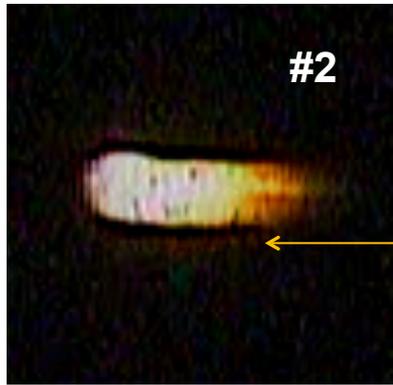
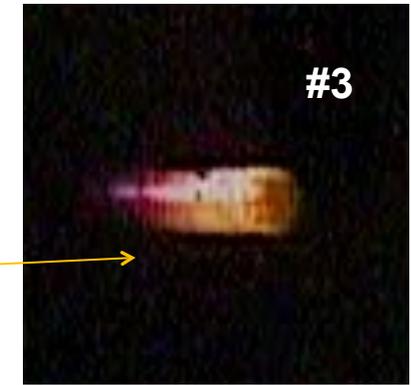
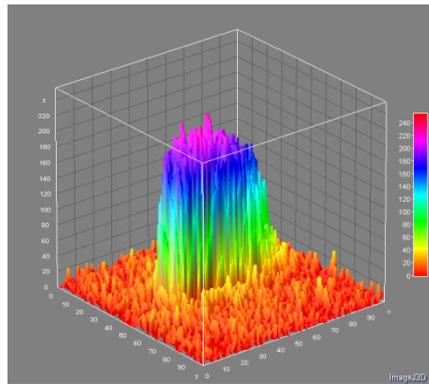
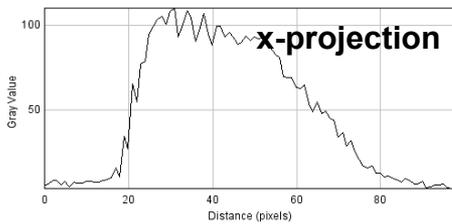
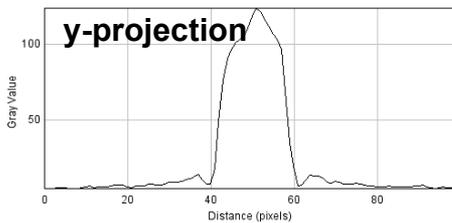
Numerical calculated
volume = intensity

2 8.6×10^4

3 9.4×10^3

intensity ratio #2/#3 ~ 9

Video file name: 11h44m58s.avi June 10, 2014

Numerical calculated
volume = intensity

2 8.6×10^4

3 9.4×10^3

intensity ratio #2/#3 ~9

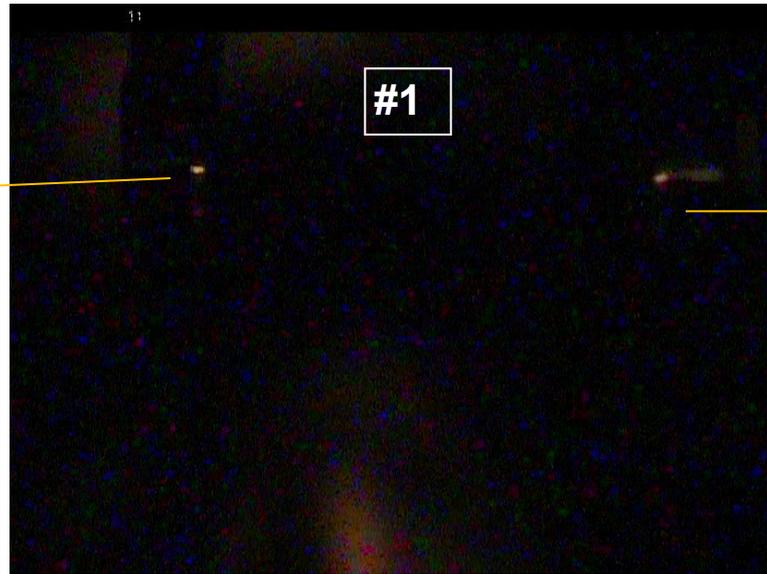
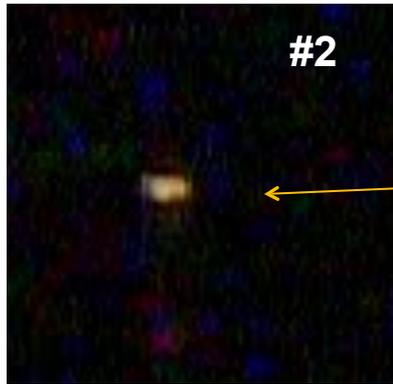
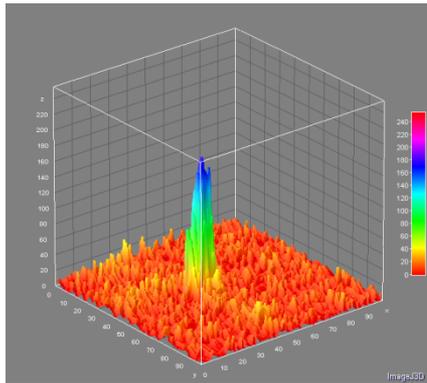
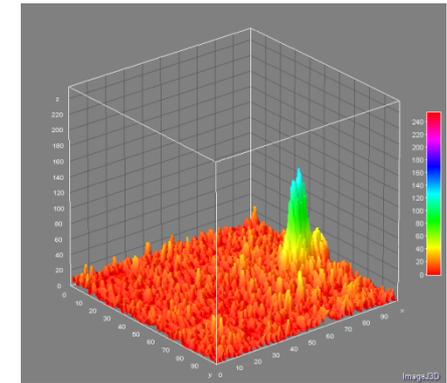
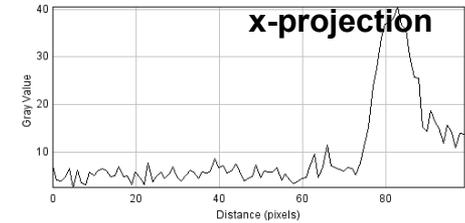
Numerical calculated
volume = intensity

2 3.4×10^3

3 1.2×10^3

intensity ratio #2/#3 ~ 3

Video file name: 11h43m23s.avi June 10, 2014

Numerical calculated
volume = intensity

2 3.4×10^3

3 1.2×10^3

intensity ratio #2/#3 ~3

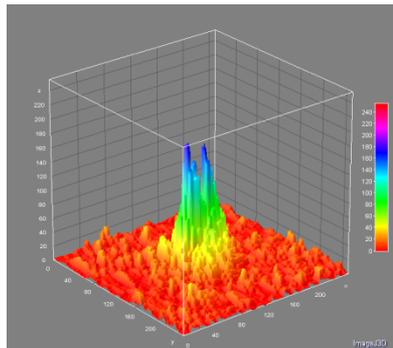
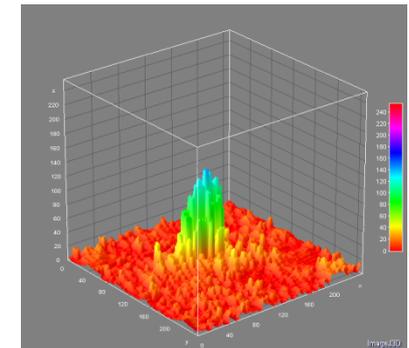
**Numerical calculated
volume = intensity**

2 7.8×10^4

3 5.4×10^4

intensity ratio #2/#3 ~ 1.4

Video file name: 17h54m40s.avi June 12, 2014

Numerical calculated	intensity ratio #2/#3	~1.4
volume = intensity		
2 7.8×10^4		
3 5.4×10^4

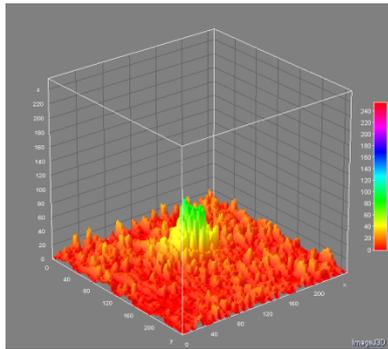
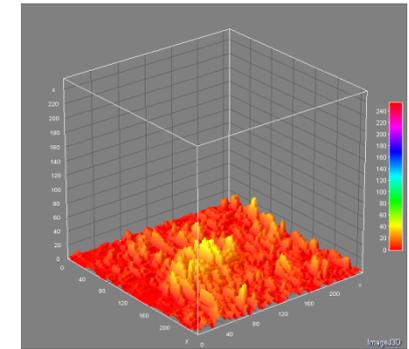
**Numerical calculated
volume = intensity**

2 4.9×10^4

3 4.2×10^4

intensity ratio #2/#3 ~ 1

Video file name: 17h53m10s.avi June 12, 2014

Numerical calculated	intensity ratio #2/#3	~1
volume = intensity		
2 4.9×10^4		
3 4.2×10^4

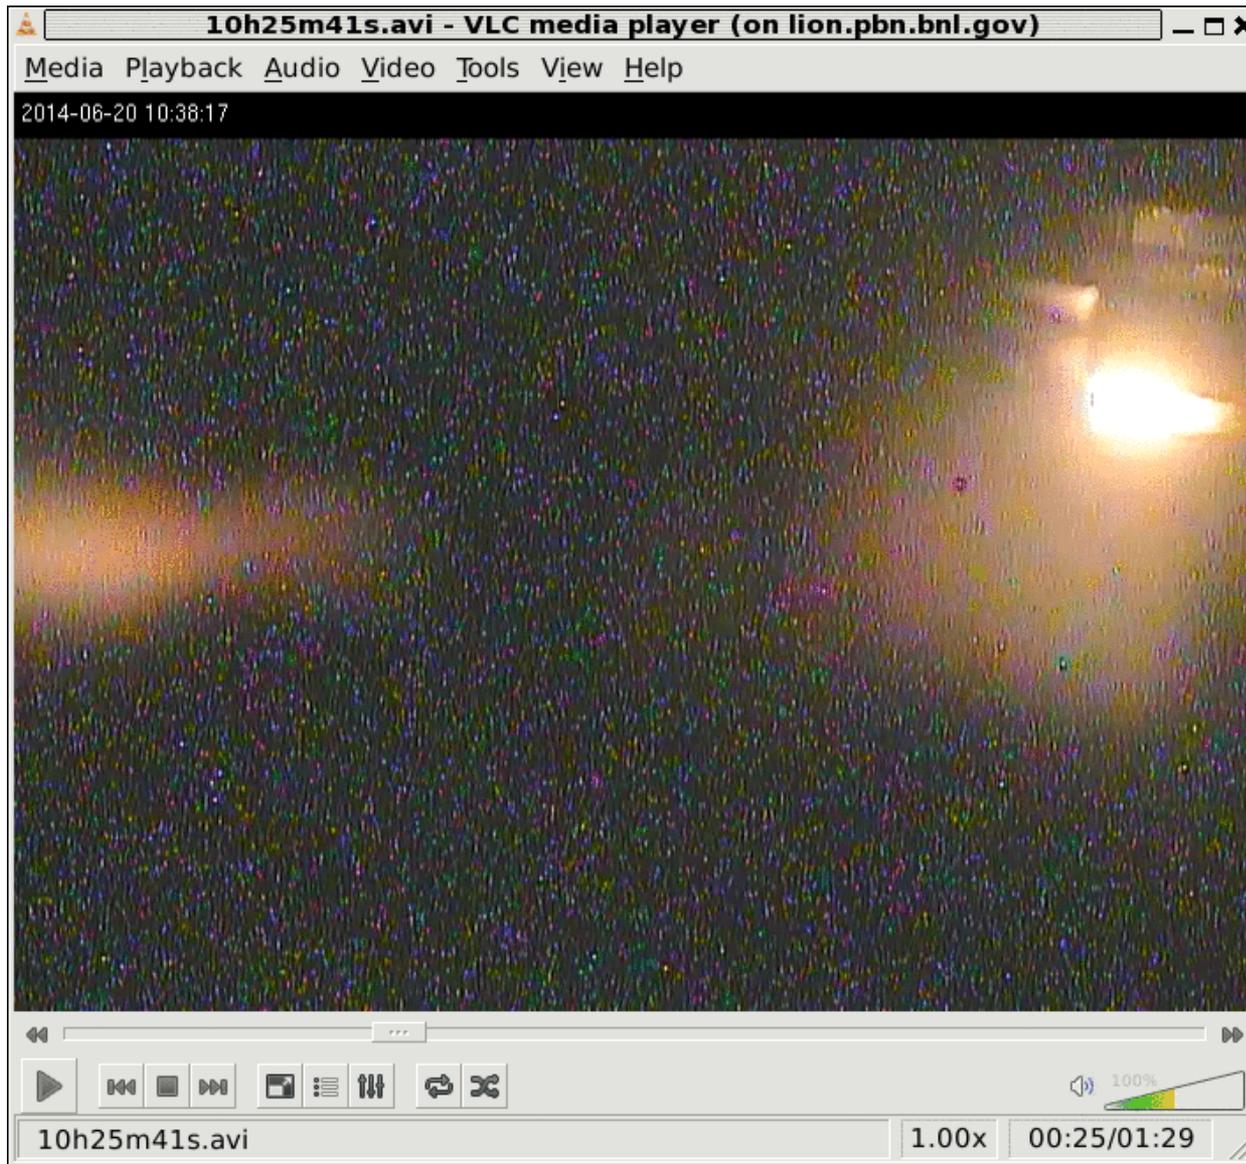
Big Flash When Switching to No-fin Targets

- June 20, 10:23-10:37. Tested B1H1, B1H3 (with fins) and B1H2, B1H4 (no fins). He3 intensity 344×10^9 .
- The two targets without fins were lost when I switched from 1-3-5 side to 2-4-6 side. A big flash happened in the process but without beam loss. Only the broken target tails were visible. Same exercise with Gold beam also showed brighter light at the time, but did not break target.
- The target with fins were tested before and after. They were not lost during the switch. In both cases there were no glowing light at both ends (unlike the Au case).
- July 4, 11:20-11:40. Tested B2V1, B2V3, B1V1(with fins0, B1V3(with fins), B2V2, B2V4. But blue1 camera didn't record any videos. So the test has not much use.

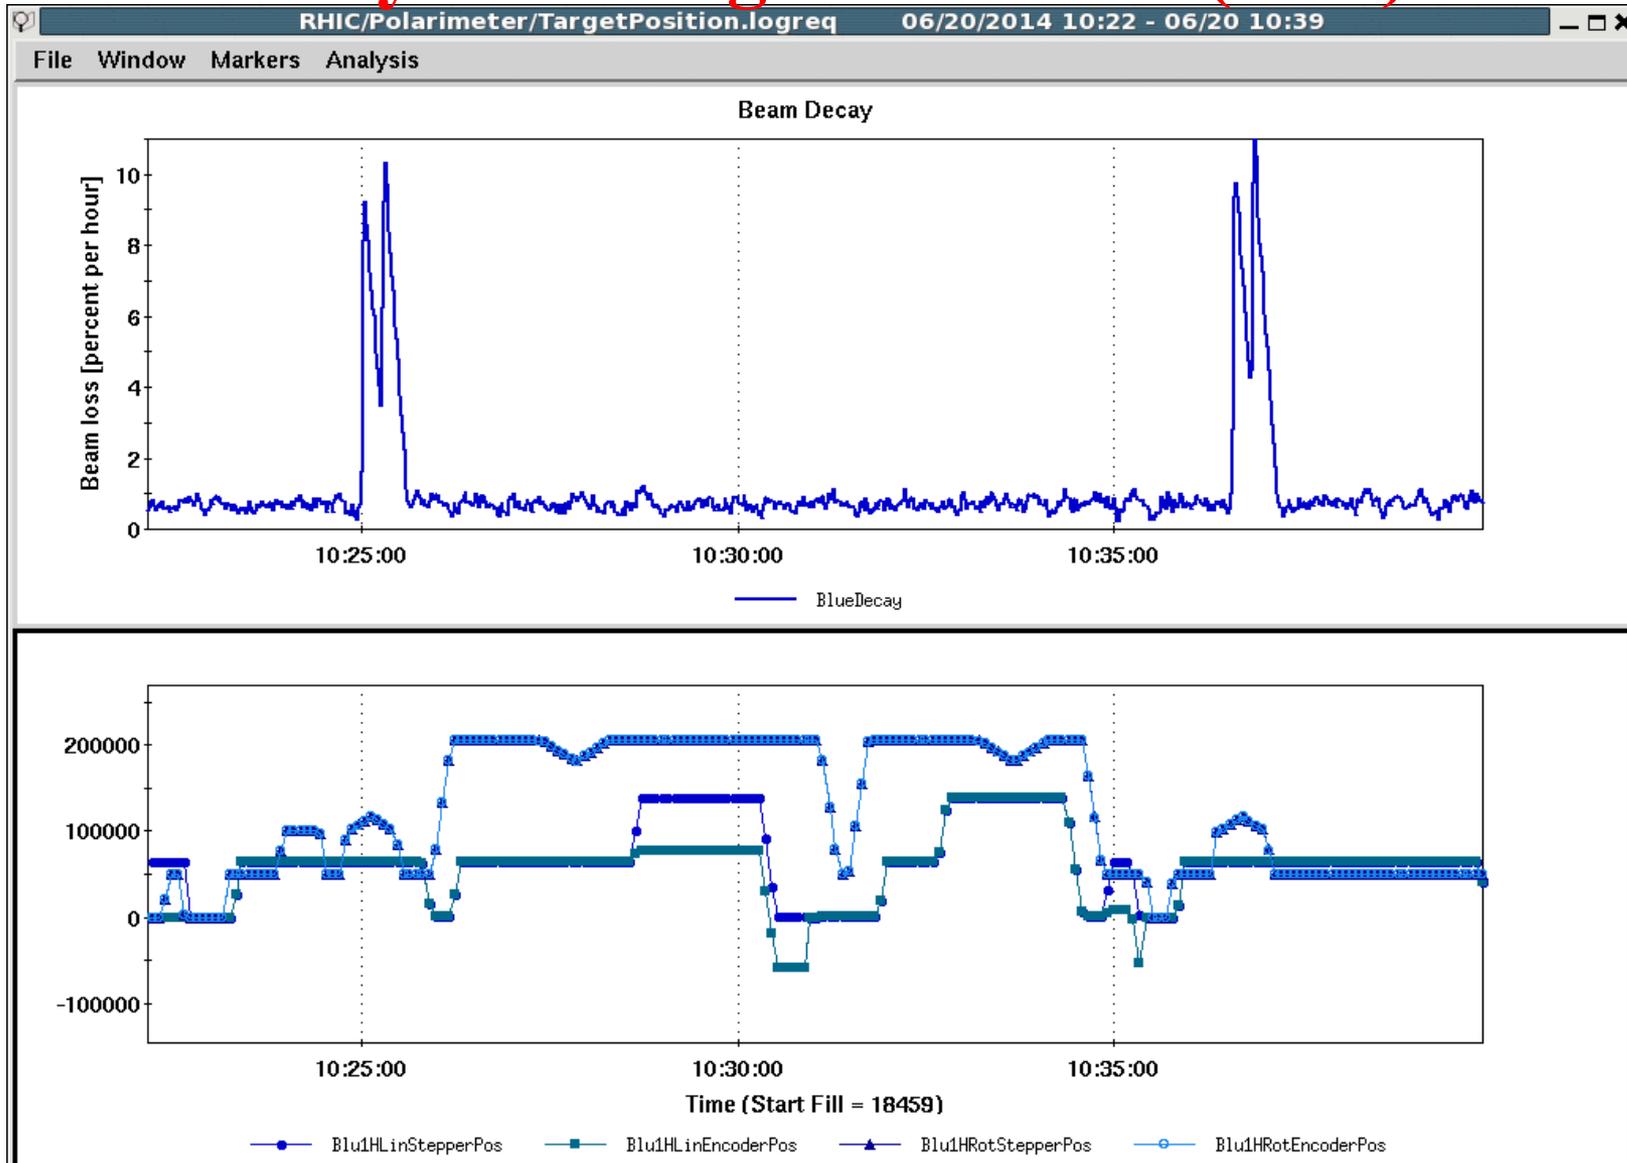
Beam Decay and Target Positions (6/20)

Beam decay and target position. Note that there is no beam decay spike around 10:26:06. There is also no decay around 10:27 and 10:32 when scanning no-fin targets into the beam. They were gone by then. Repeated target with fin again at 10:37 confirmed that target was still there. So only the no-fin targets were affected.

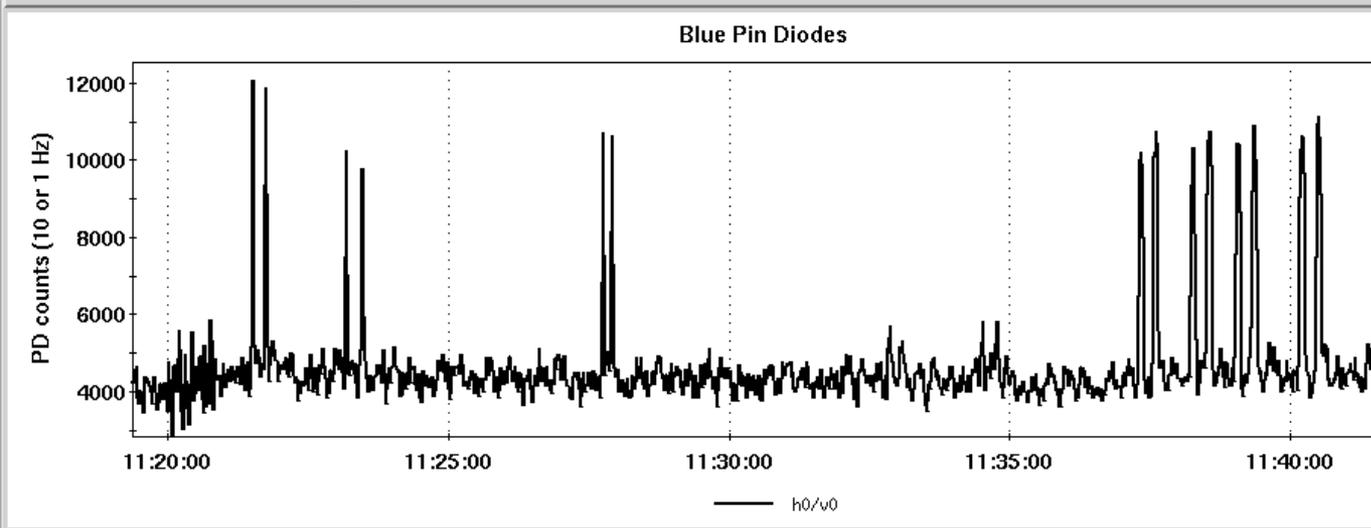
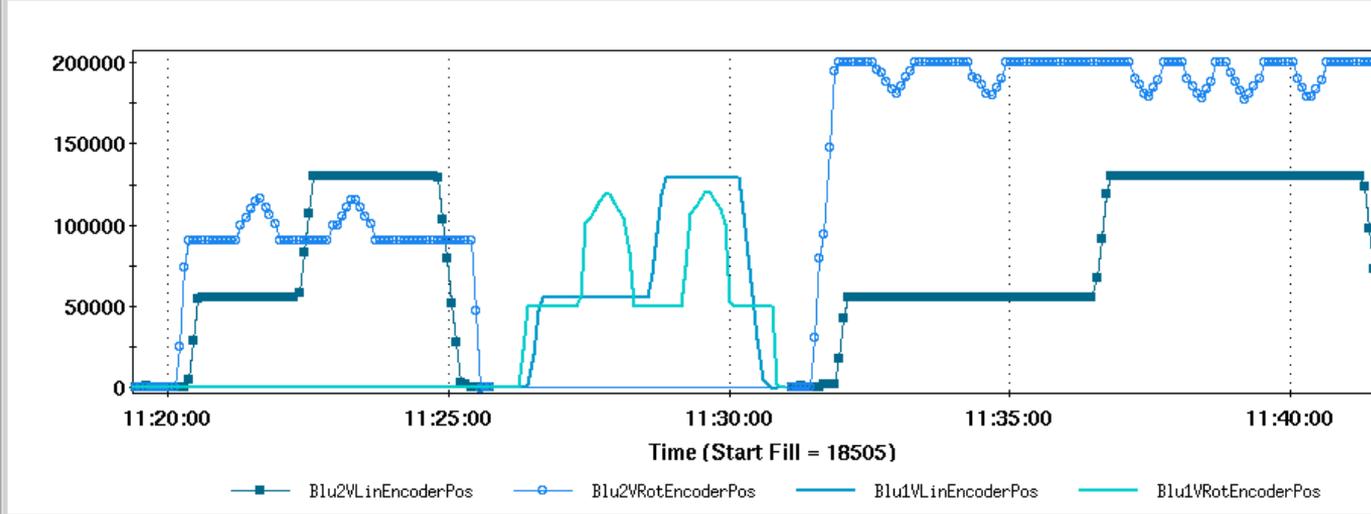
July 4 Beam Test with Vertical Targets

- Idea was to compare B1V (with fins) and B2V (without fins). But the blue1 camera did not work.
- Target B1V3 (with fins) is not there.
- Quite different target size for B2V2.

Time = Fri Jul 4 11:31:47 2014+246ms, Blu2VRotStepperPos = 147436
Time = Fri Jul 4 11:37:18 2014+585ms, Blu2VRotStepperPos = 185818
Time = Fri Jul 4 11:41:44 2014+269ms, Blu2VRotStepperPos = 200121

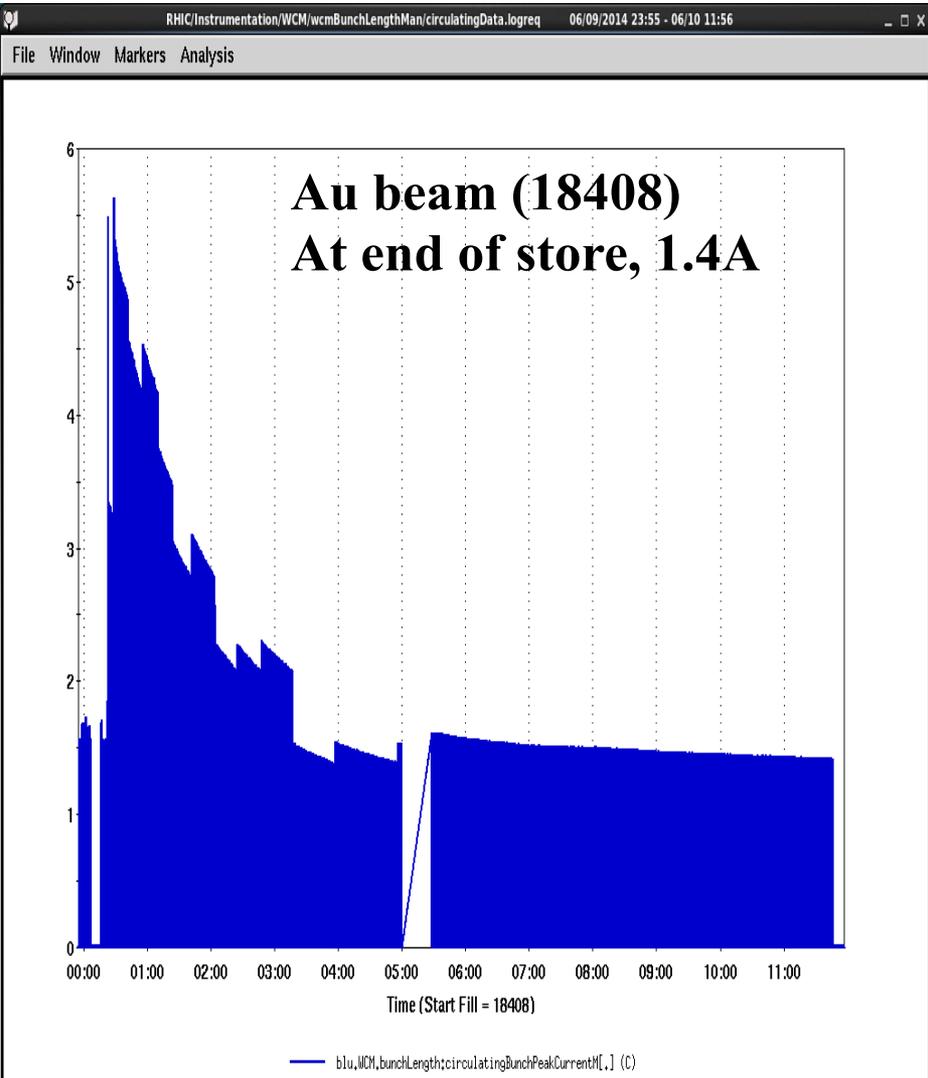
Higher Current at End of Store for He Beam was Likely the Reason for the Target Break

Time = Tue Jun 10 11:44:27 2014+304ms, blu.WCM.bunchLength:circulatingBunchPeakCurrentM[,] = 1.4178

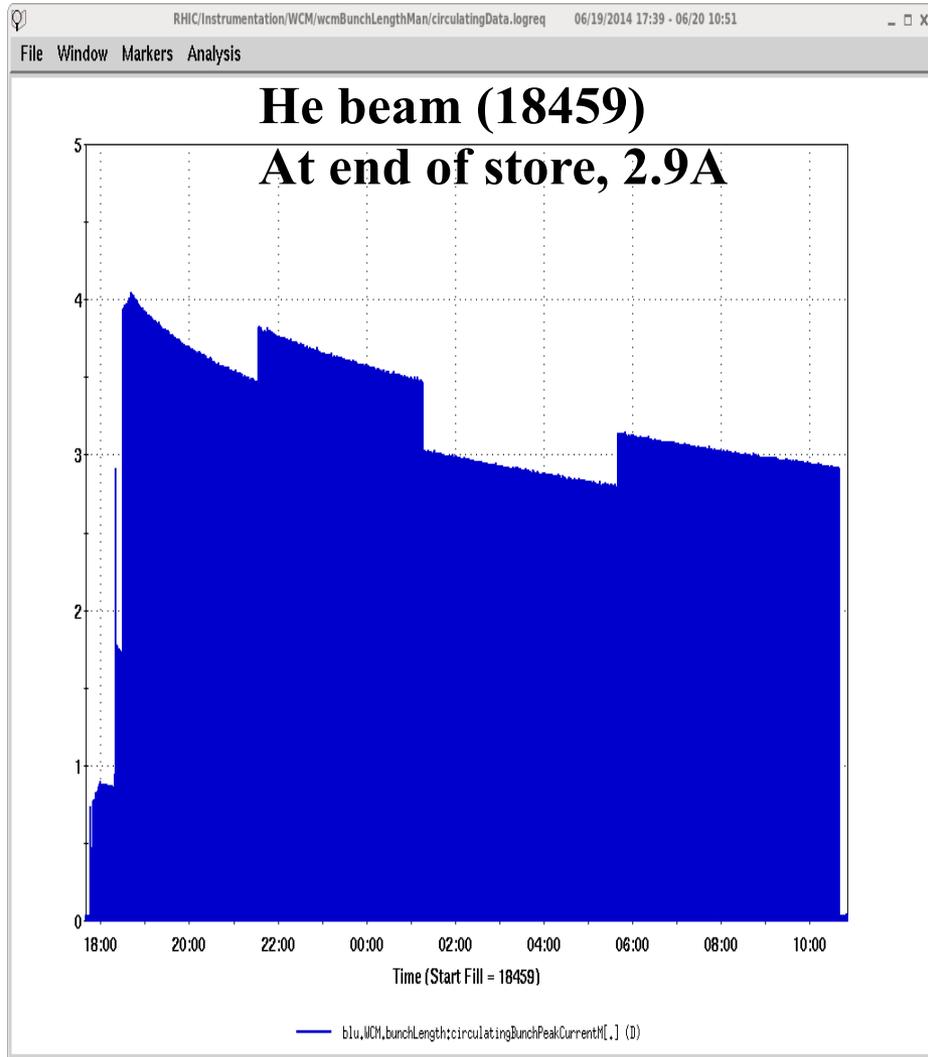
Time = Fri Jun 20 05:35:03 2014+285ms, blu.WCM.bunchLength:circulatingBunchPeakCurrentM[,] = 2.7868
Time = Fri Jun 20 05:41:48 2014+285ms, blu.WCM.bunchLength:circulatingBunchPeakCurrentM[,] = 3.12302
Time = Fri Jun 20 10:40:00 2014+285ms, blu.WCM.bunchLength:circulatingBunchPeakCurrentM[,] = 2.90825

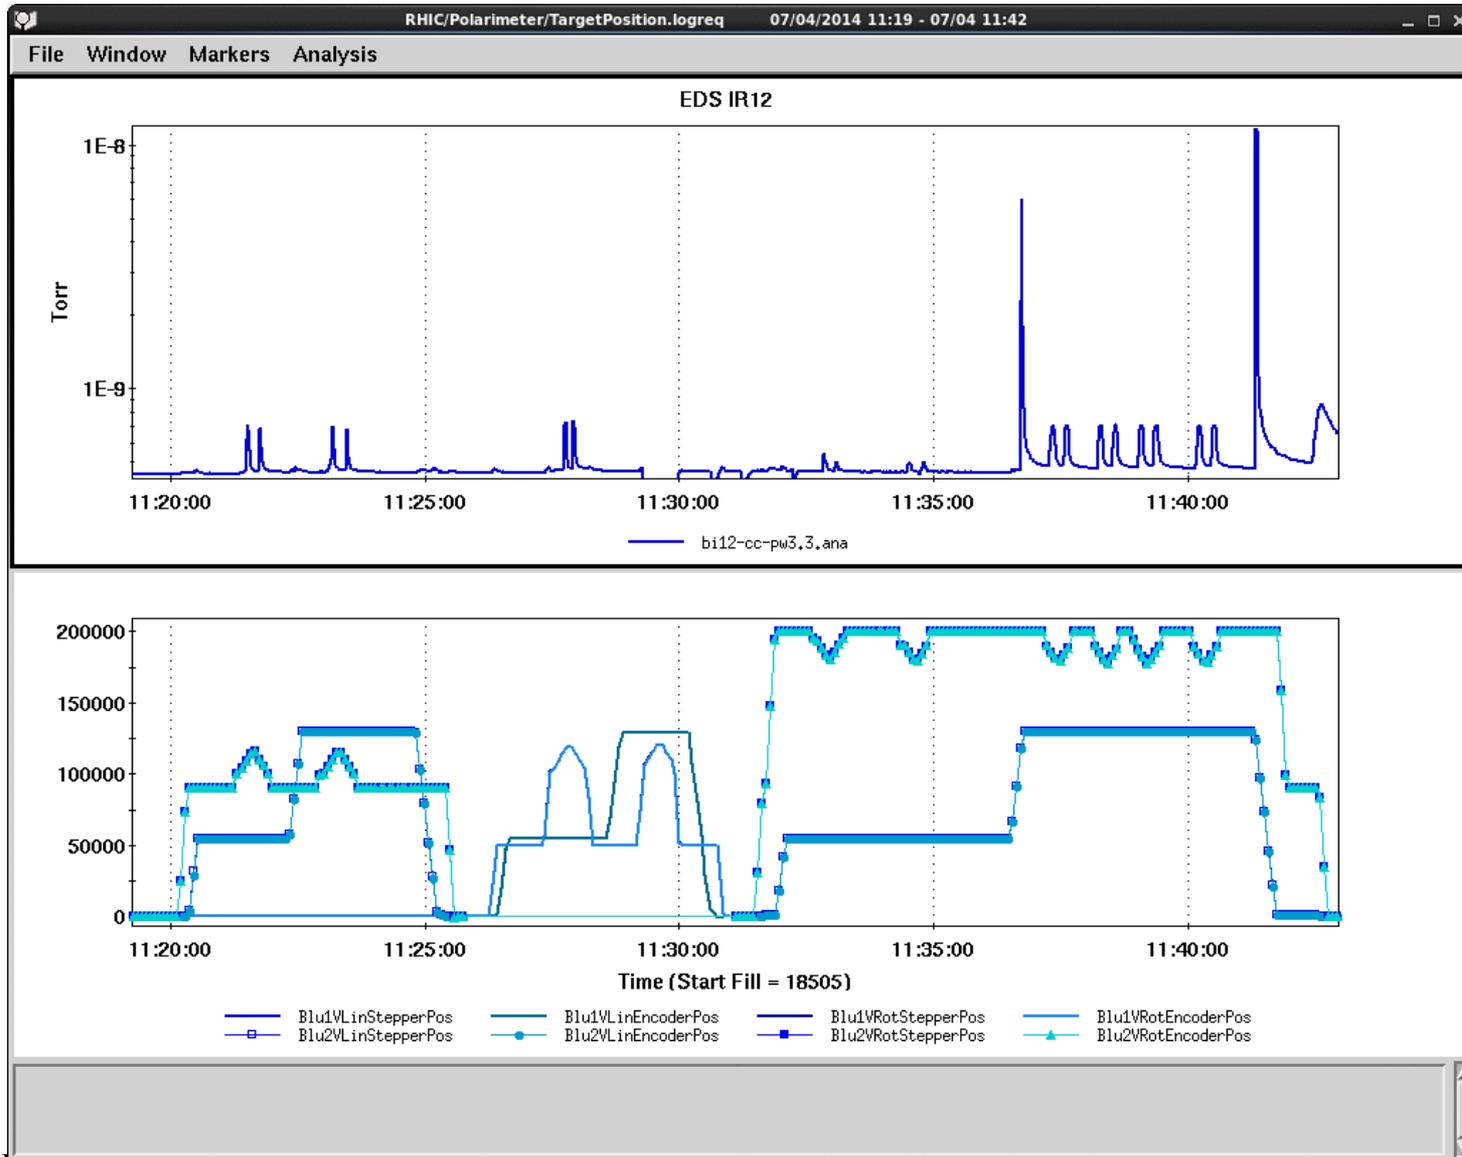
Target Position and Vacuum Pressures(7/4)

Some vacuum spikes took longer time to go away.

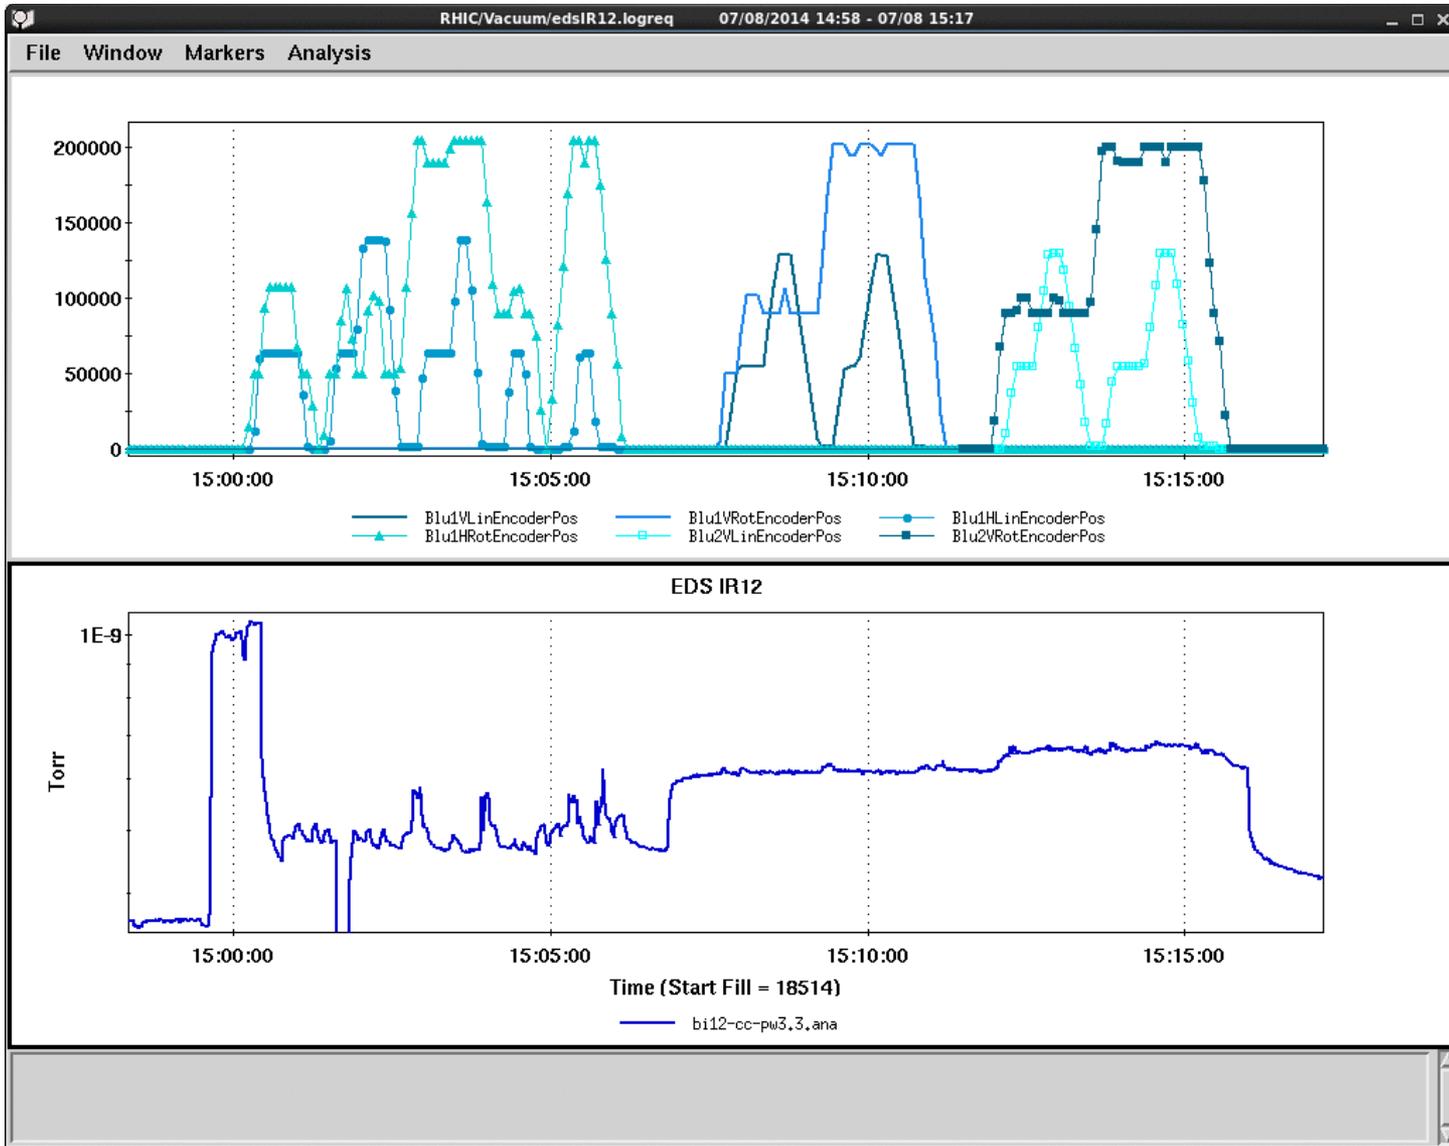
Target Position and Vacuum Pressures(7/8)

Vacuum spike structures are different from with beam. Probably some pumps were turned off?
